BRUSSELS HERITAGE

La Grand-Place, Brussels
inscribed on the World
Heritage List in 1998

THE RESTORATION OF AN EXCEPTIONAL DECORATIVE ENVIRONMENT

THE RESTORATION WORKSITE 2004-2018

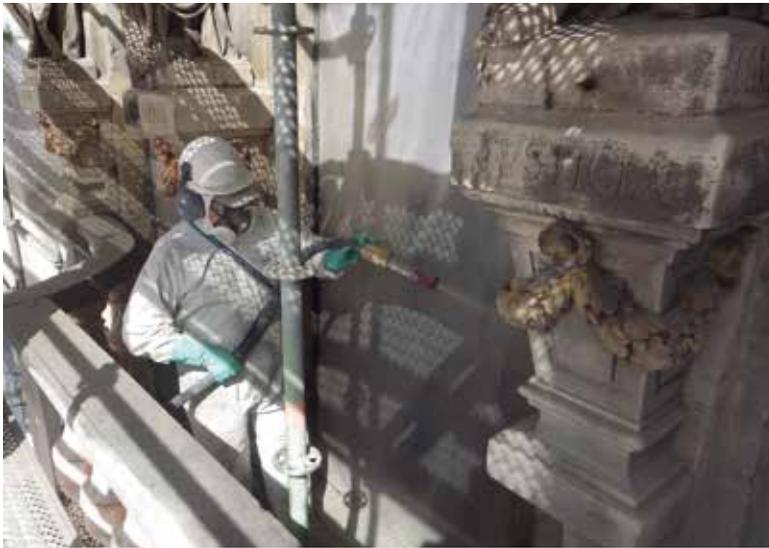
Le Renard/De Vos, cleaning the pedestal of the statue of *La Justice/Justitia* (Pierre Comein, 1884). Euville stone. Low pressure hydro-pneumatic swirling vortex technique (© HHU, 2014).

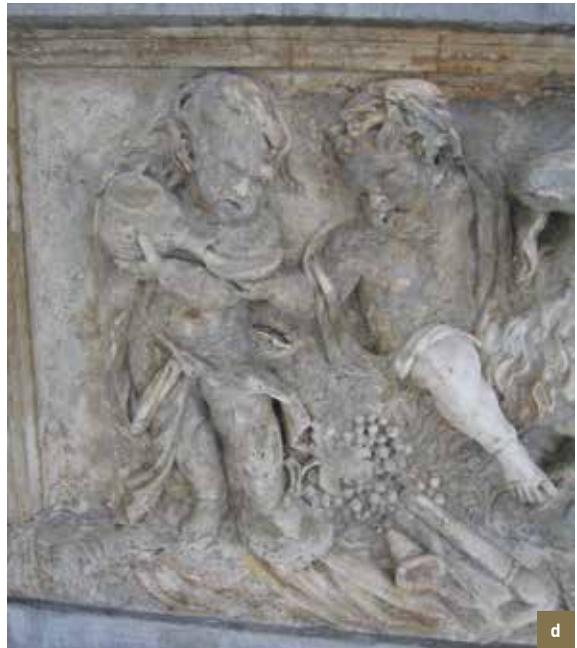
La Maison des Brasseurs/Het Brouwerhuis. Details of one of the apron panels on the 2nd floor depicting the harvest (Pierre Van Dievoet, 1698). Most likely Avesnes stone. a) Build-up of dirt on sculpted putti prior to restoration, with partial cleaning on the left; b) Application of compresses composed of an ammonia-based cellulose paste to soften the black crust; c) Finalising cleaning using a micro-sandblaster; d) Condition after cleaning (© HHU, 2004).

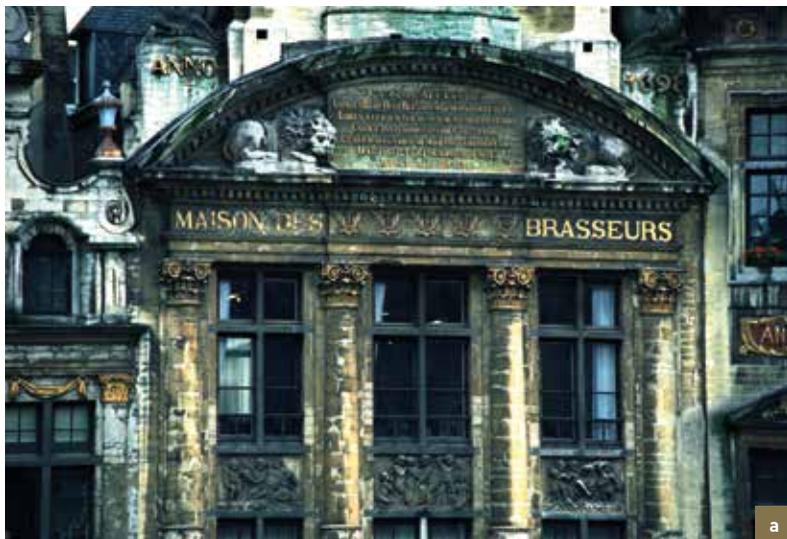
La Maison des Brasseurs/Het Brouwerhuis. a) Condition before restoration: biological growth (moss), dirt and black crust (atmospheric pollution), metal oxide stains, etc. (© HHU, 2000); b) Condition after restoration (© Utopix, M. Ploton, 2018).

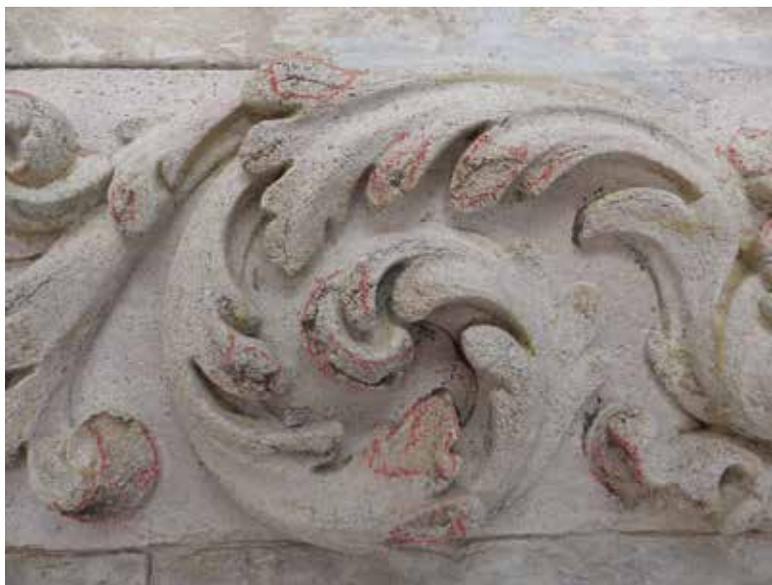
La Brouette/Den Cruywagen. Detail of scrollwork with red chalk marking the parts to be repaired with smoothing mortar. Euville stone (© HHU, 2014).

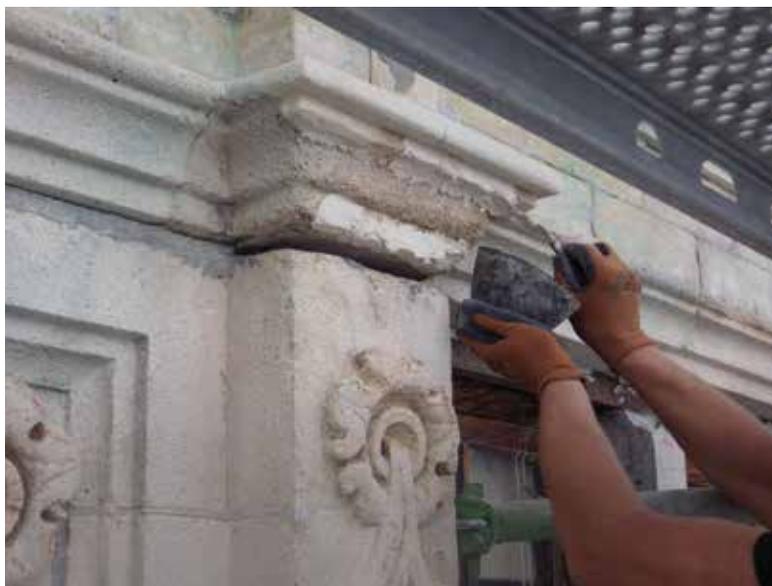
La Brouette/Den Cruywagen. Mouldings undergoing restoration and repair with smoothing mortar. Euville stone (© HHU, 2014).

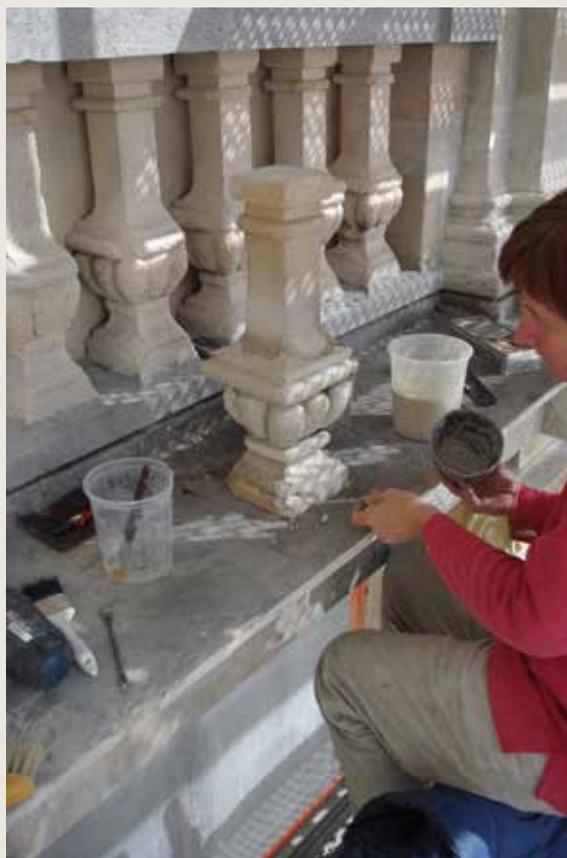
Le Pigeon/De Duive. Detail of a baluster undergoing restoration and repair with smoothing mortar. Marble type Euville stone (© HHU, 2012).

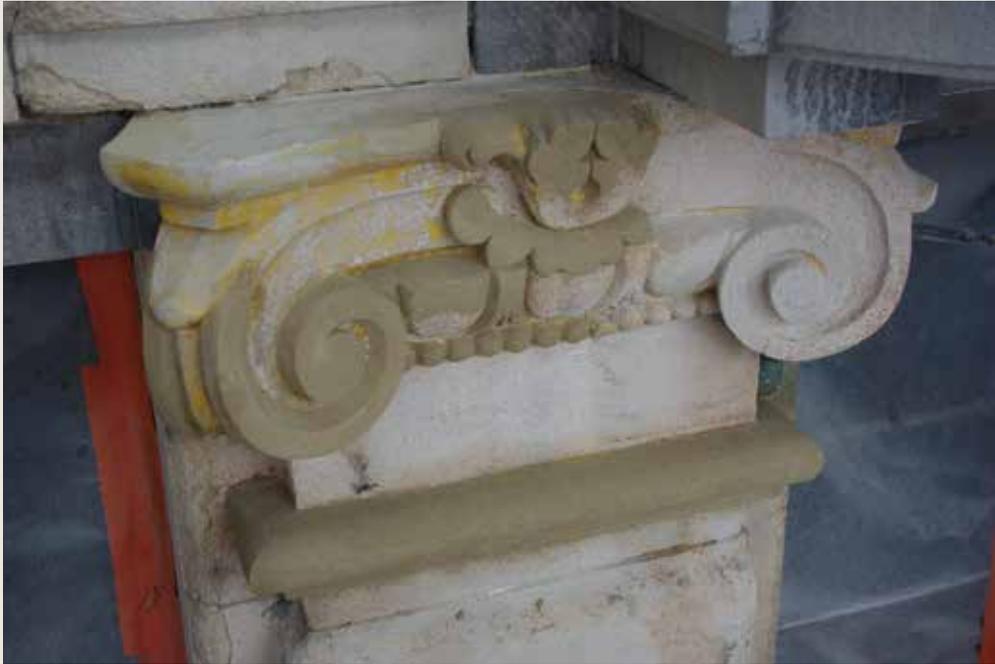
L'Ange/Den Engel. Capital undergoing restoration. Euville stone (© HHU, 2012).

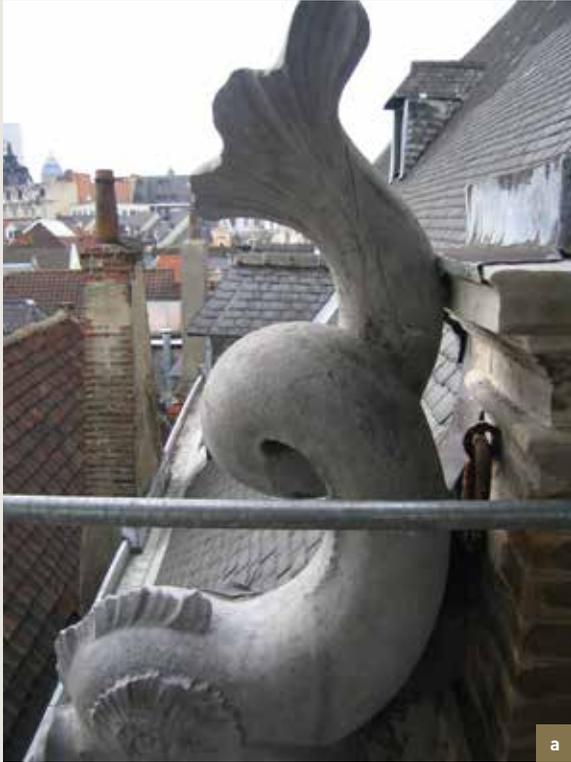
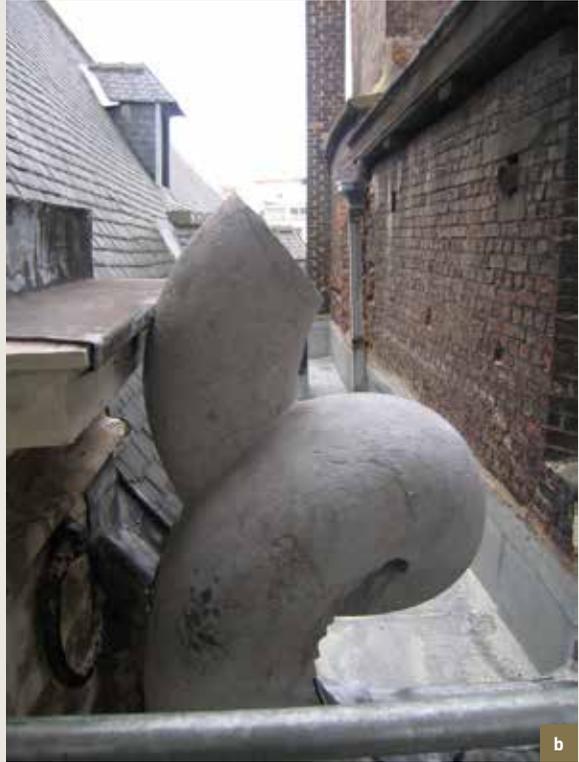
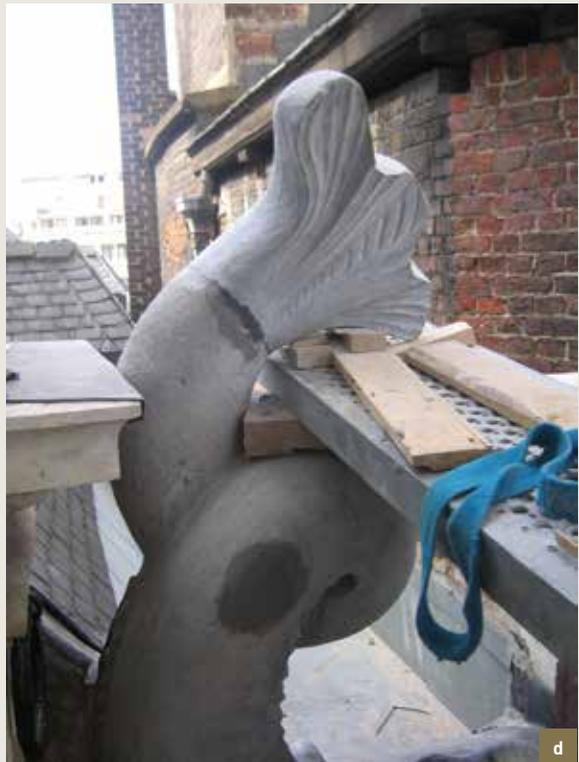
La Rose/De Roose. First floor, volute on a capital undergoing restoration: a) Integration of a Massangis stone graft; b) Sculpting in progress; c) Finished element (© HHU, 2008).

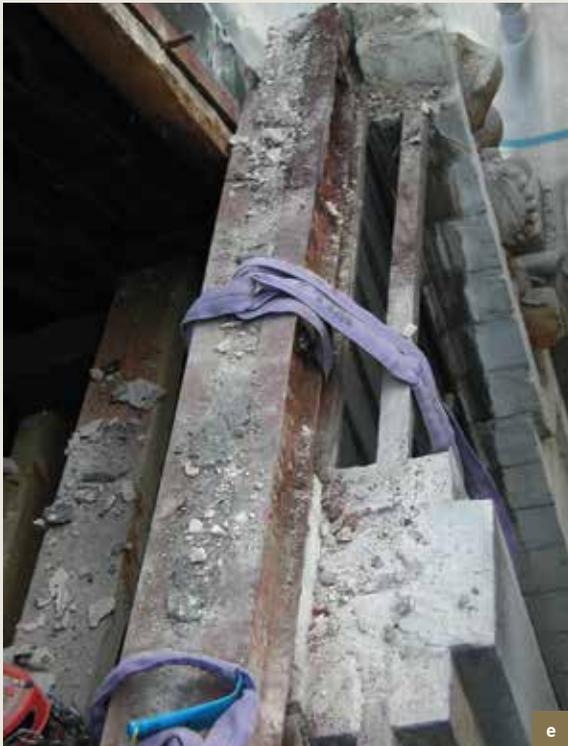
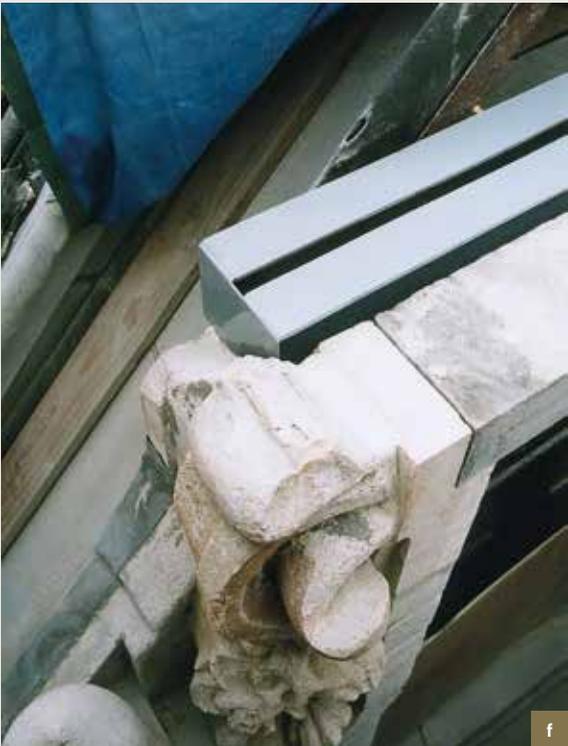
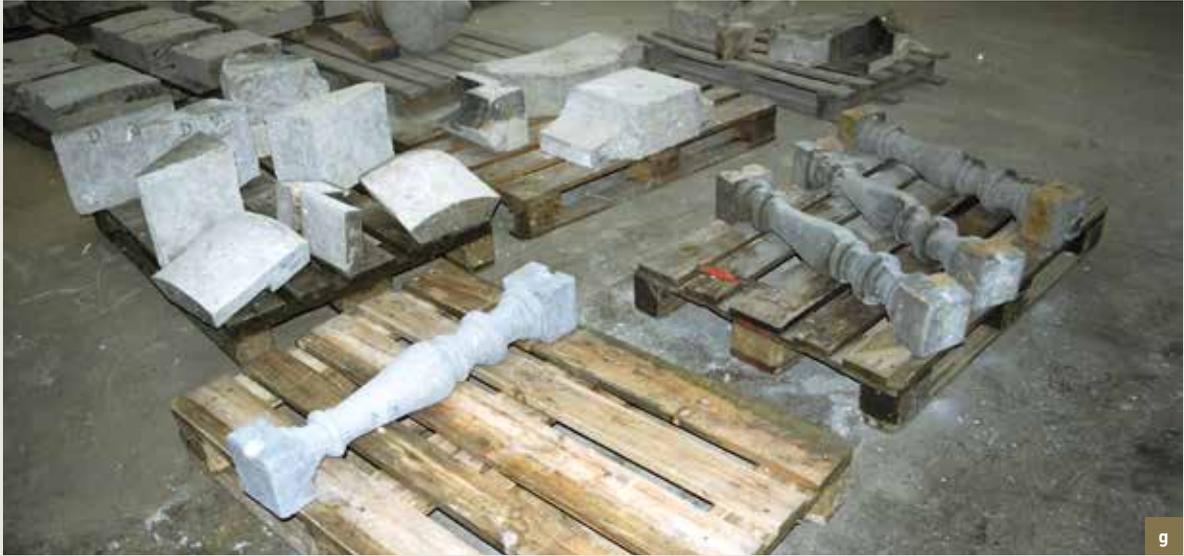
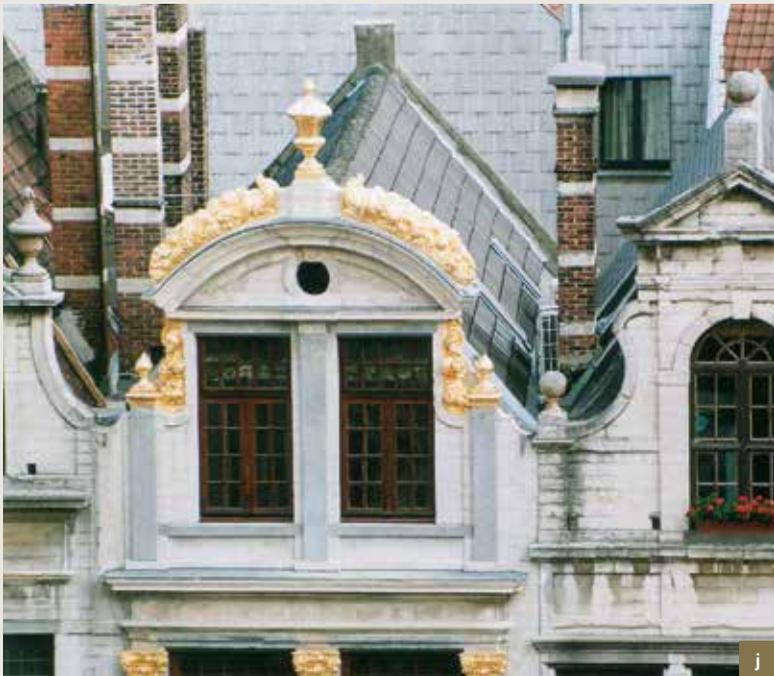
L'Âne/Den Ezel. Stages in the restoration of the arched pediment, from pre-restoration condition to complete reassembly. Euville stone. a) Damaged condition; b) Disassembly in progress; c) Old numbering of stones and corroded staple; d) New marking of stones prior to disassembly; e) Removal of corroded metal beams; f) Replacement of metal beams; g) Cleaning and restoration of stones in workshop; h) and i) Reassembly of restored elements; j) General view after these operations (© HHU, 2003-2004).

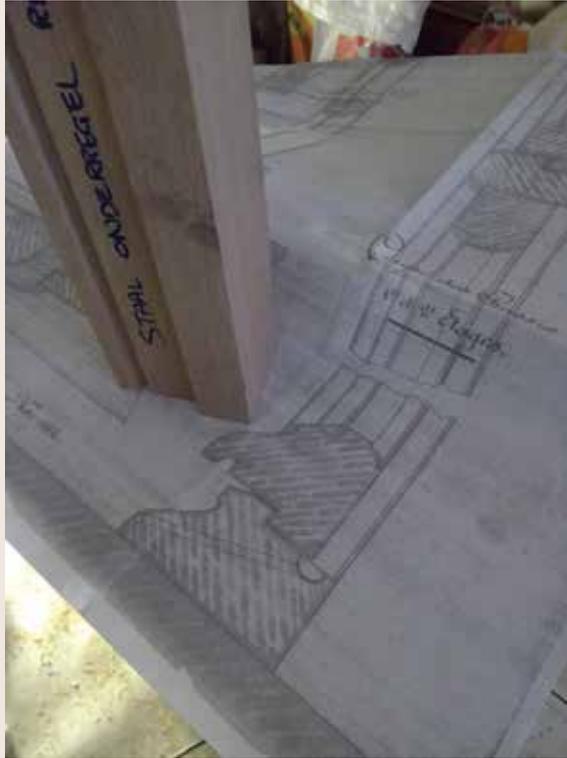
Le Paon/Den Pauw. Full-scale drawings from the archives helped to recreate the sections accurately (© HHU, 2015).

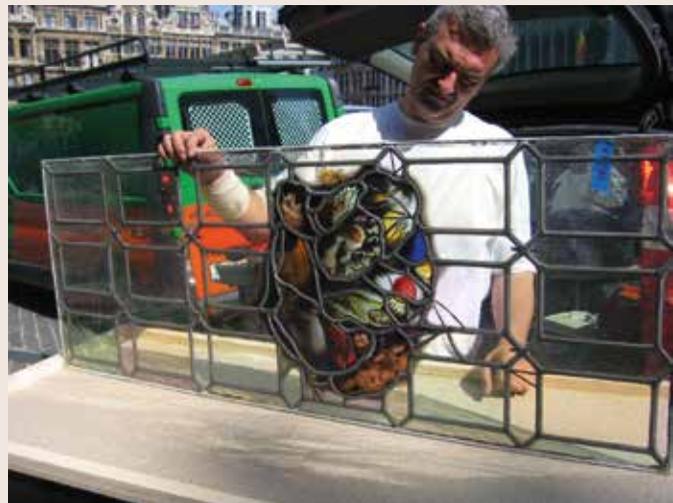
La Maison des Brasseurs/Het Brouwerhuis. The noticeable bulge in the stained glass was straightened after the glass had been removed (© HHU, 2008).

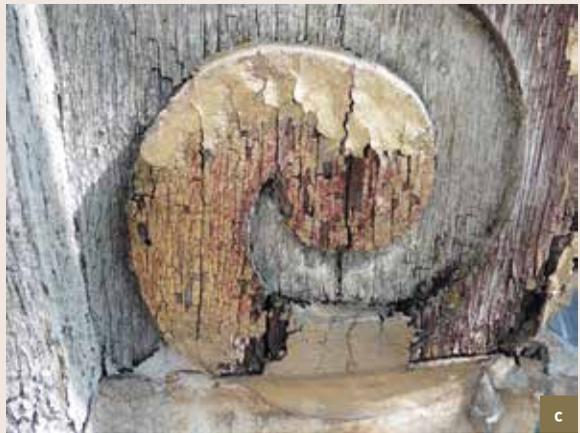
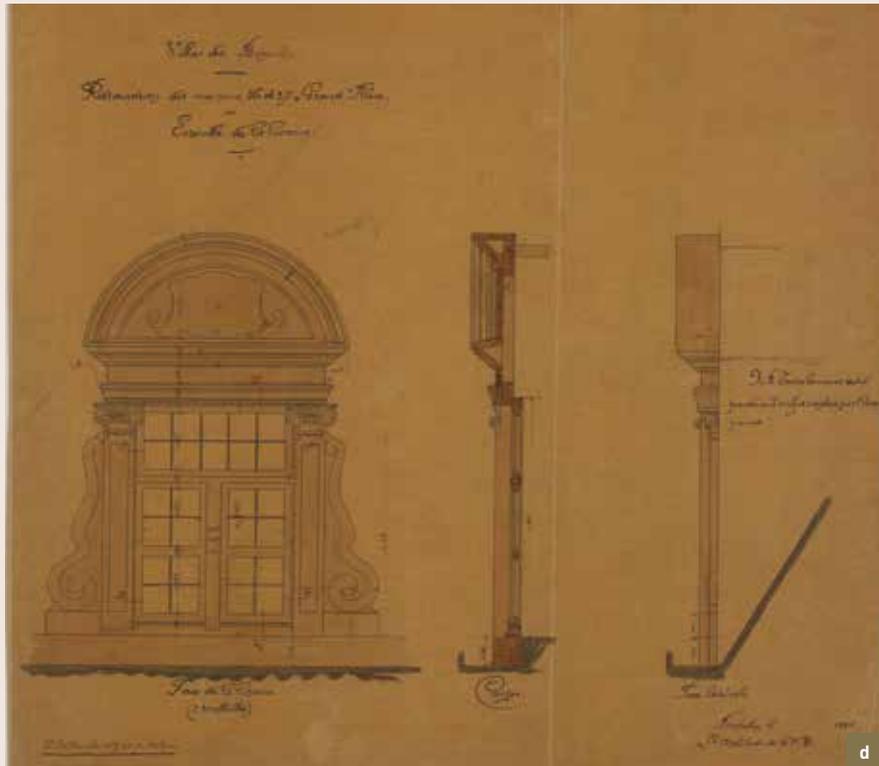
Le Petit Renard et le Chêne/Het Vosken en Den Eycke: Restoration of two oak dormer windows. a) Windows before restoration work; b) and c) Damaged wood and lead flashing, cracks, flaking paint and gilding; d) Archive drawing; e) Restoration in workshop with reinforcement of consoles and integration of grafts, replacement of parts that were too badly damaged; f) consolidation of a capital with insertion of grafts (© HHU, 2016 and AVB).

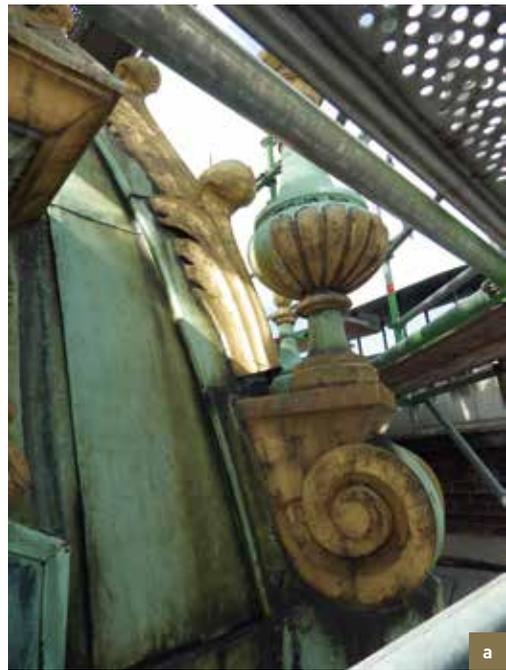
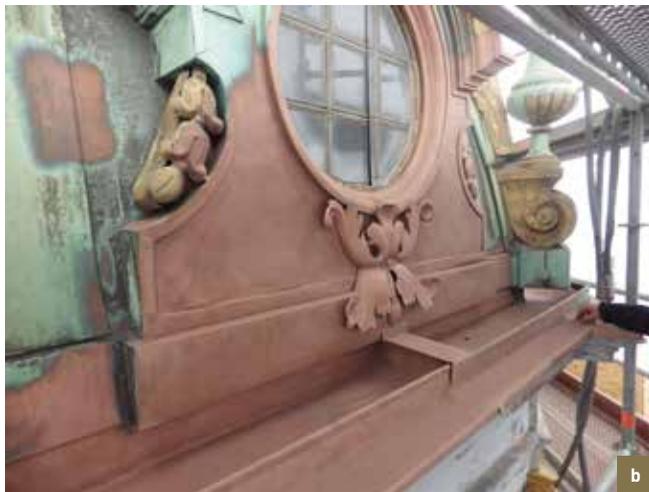
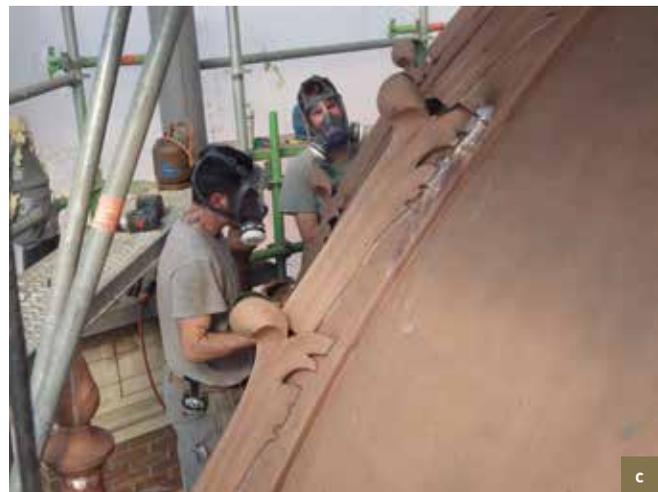
The copper cupola of the *Roi d'Espagne/Den Coninck van Spaignien* was dirty and had gradually assumed a natural green patina. An inspection revealed problems with the welding. All the copper elements were thoroughly sandblasted in order to expose and restore the copper.

Le Roi d'Espagne/Den Coninck van Spaignien. Stages in the restoration of the copper cupola. a) Condition of cupola before restoration with dirt and green patina; b) and c) Sandblasting in progress to expose and restore the copper in order to replace damaged parts and repair defective welding, among other things d) Cleaning and polishing using steel wool (© HHU, 2015).

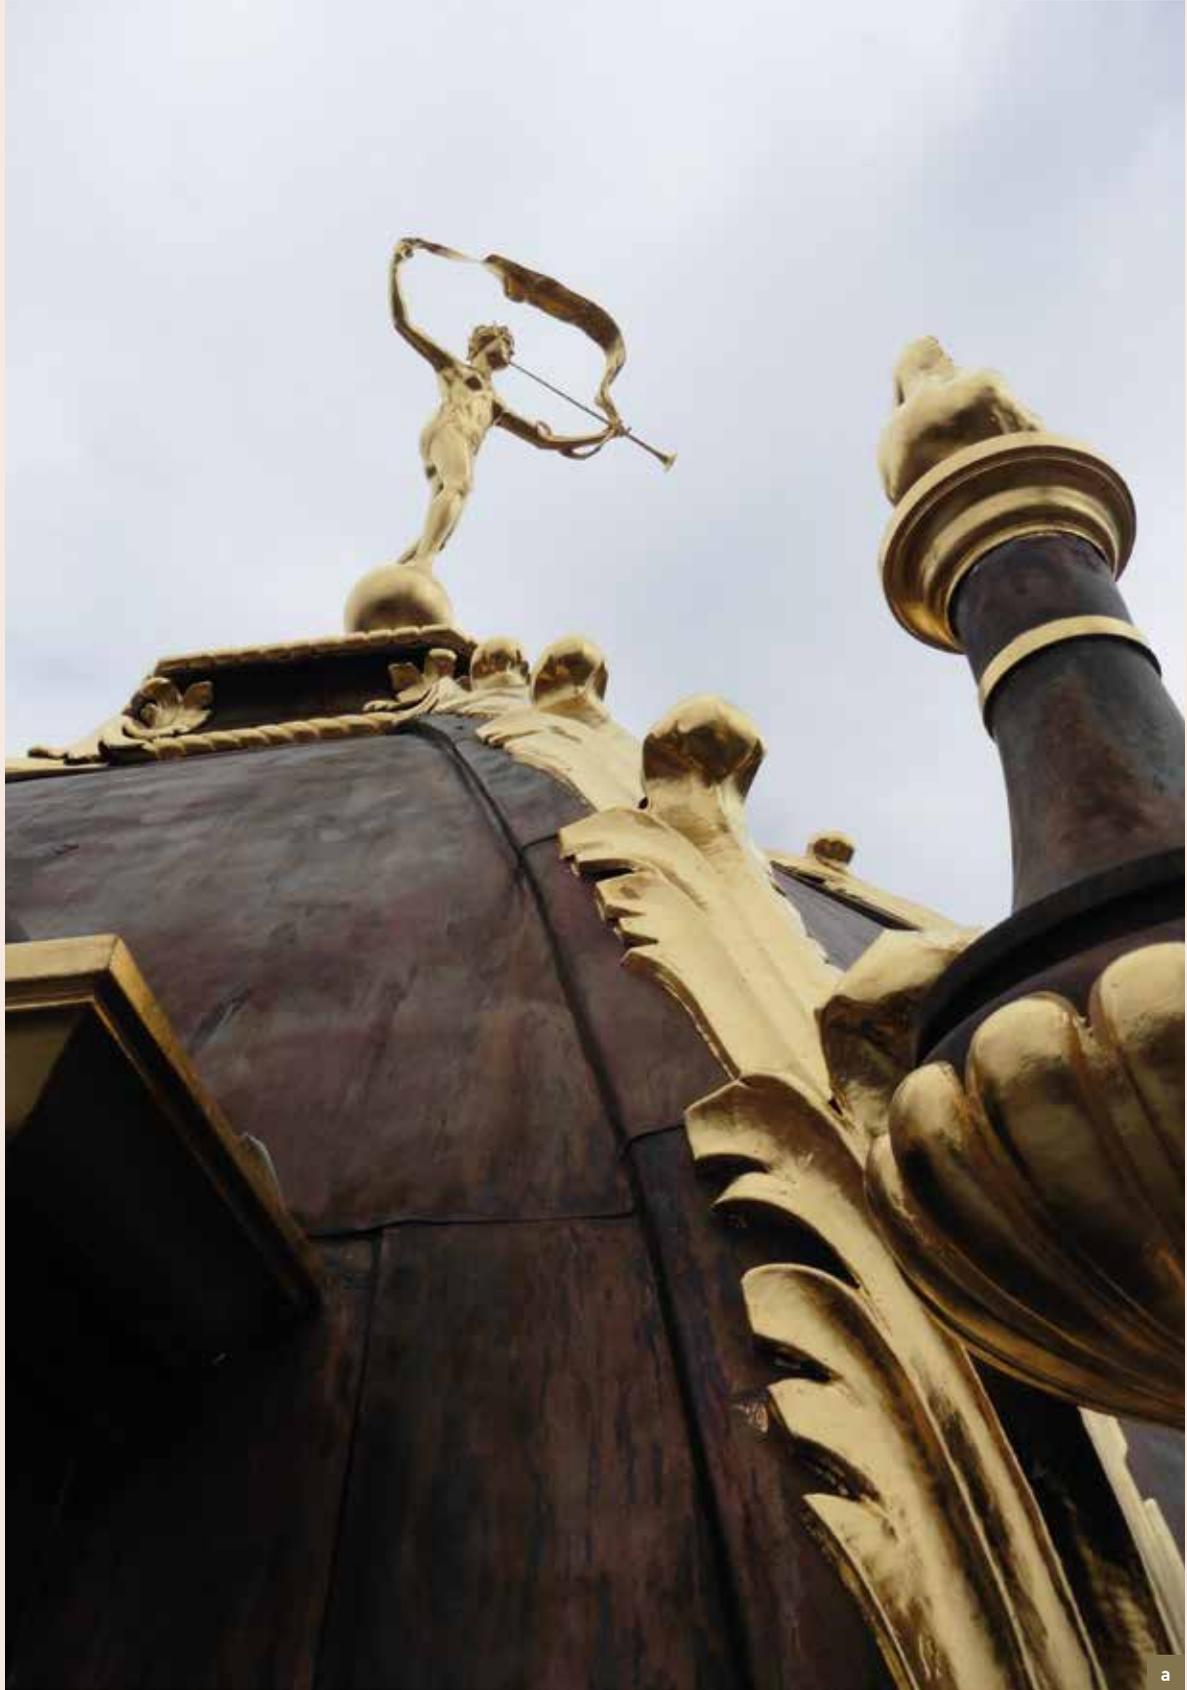
Le Roi d'Espagne/Den Coninck van Spaignien. Stages in the restoration of the bronze statue of *La Renommée/De Faam* (or *La Fortune/Het Fortuin*, Paul Du Bois, 1902). a) *La Renommée/De Faam* after restoration; b) Detail of the head of the statue before cleaning; c) Statue being painted (preparatory base layers for gilding); d) Gilded statue (© HHU, 2014-2015).

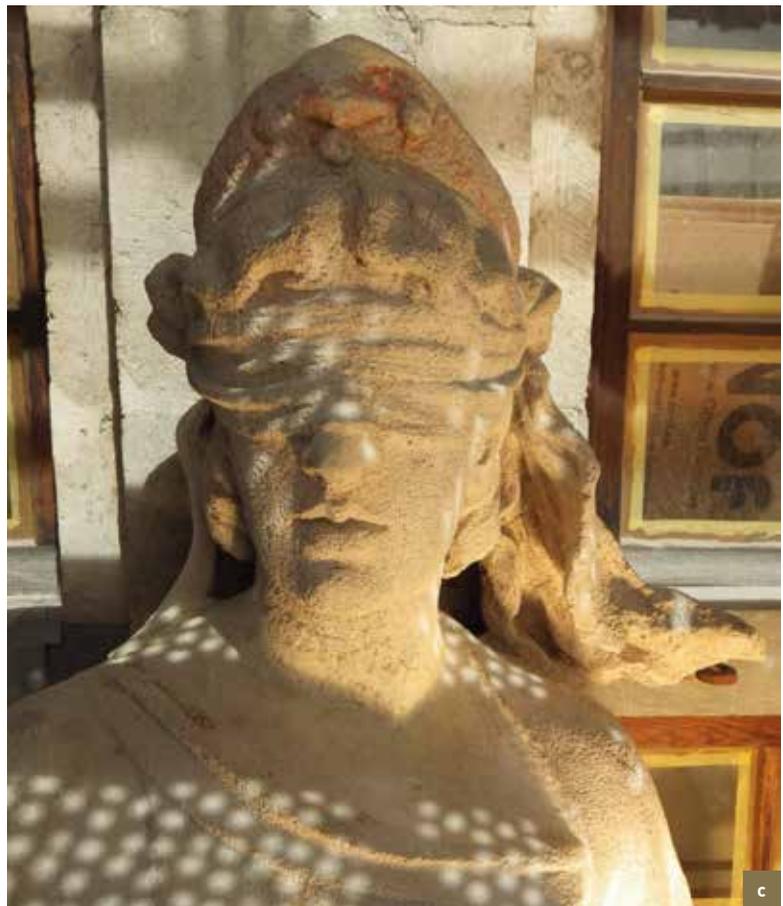
Le Renard/De Vos. Detail of the statue *La Justice/Justitia* (Pierre Comein, 1884). Euville stone. a) Before cleaning. Build up of dirt, peripheral crack on head; b) After cleaning; c) After the restoration of the stone (securing of the cracked head, patching with mortar using photographs of models) (© HHU, 2014-2015).

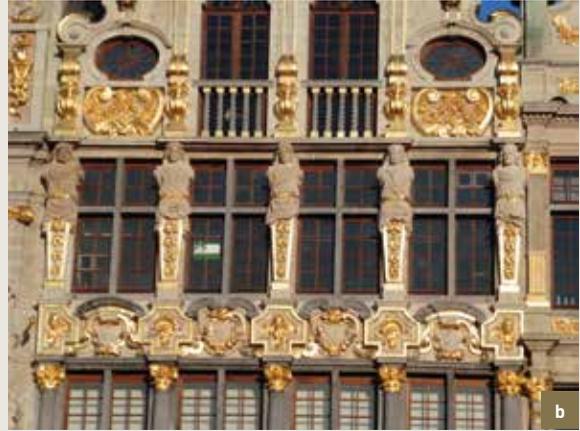
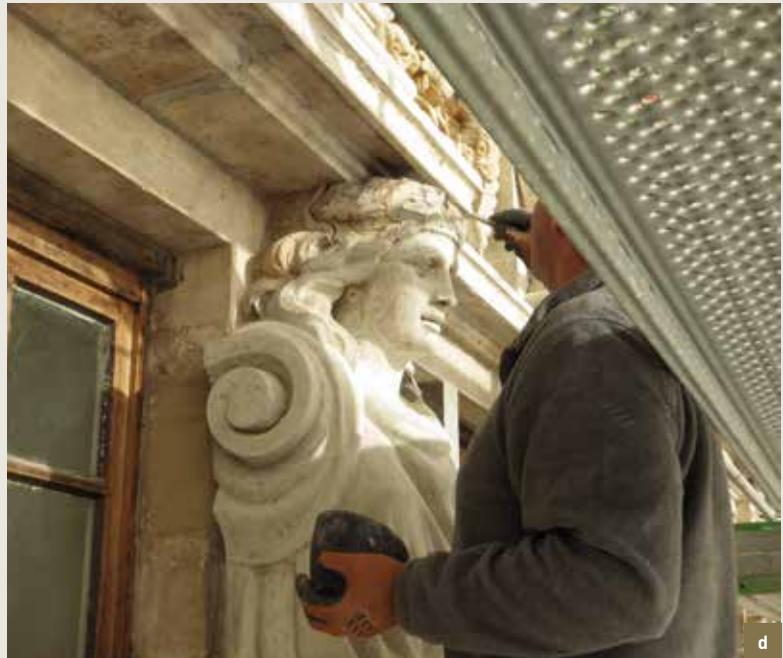
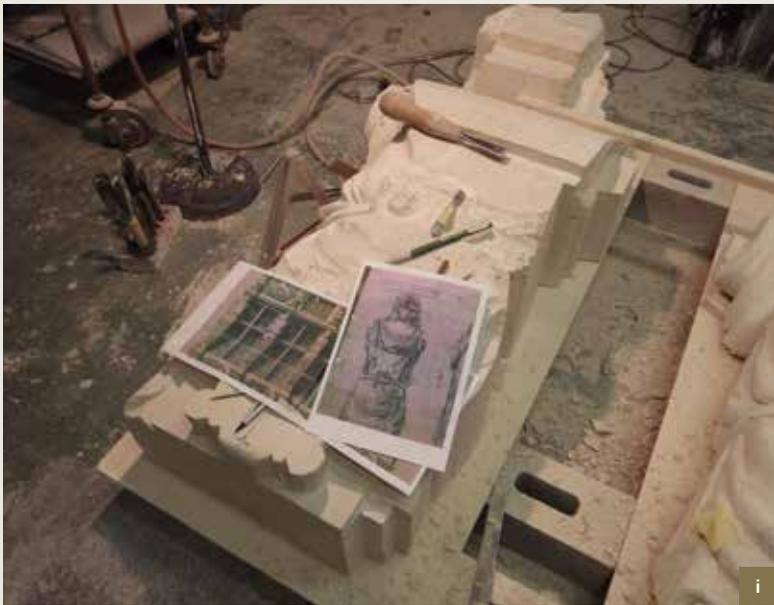
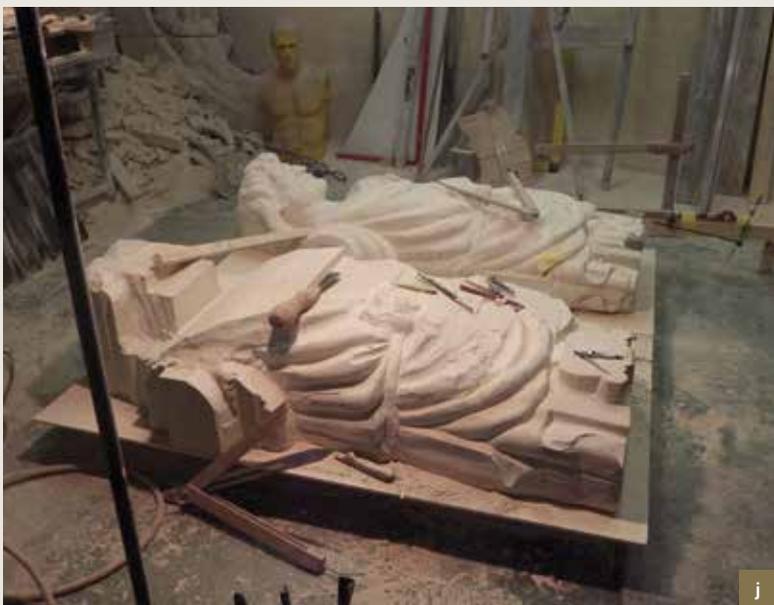
lar-like form) on *Le Sac/Den Sack*. Very badly damaged by pollution and ad hoc repairs, they were replaced with Savonnière stone.

Le Sac/Den Sack. Stages in creating reproductions of the five statues based on the original models. a) The five covered statues (terms) before their replacement (© HHU, 2016); b) The five sculptures after replacement; c) and d) *In situ* repairs to statues that were too badly damaged (the metal elements had caused cracks and chips in the stone) with a view to making casts of the works; e) and f) Casting with silicone and fibreglass-reinforced polyester resin; g) Transportation of original elements (for documenting) after unmoulding; h) Manufacture of new sculptures (Savonnière stone) using the pointing method and based on the plaster model; i) and j) Work in progress with historical drawings and sculpting tools; k) and l) Mounting of new sculptures (© HHU, 2014-2015).

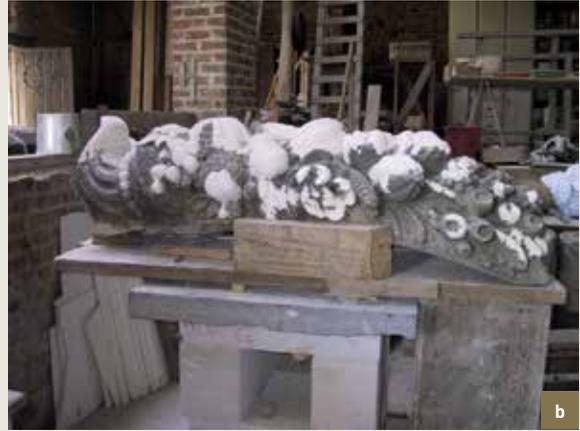
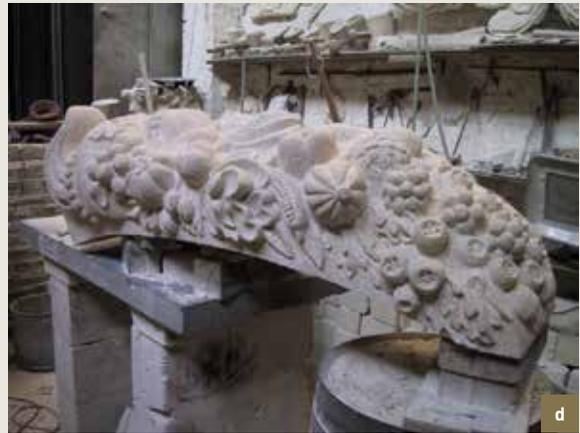
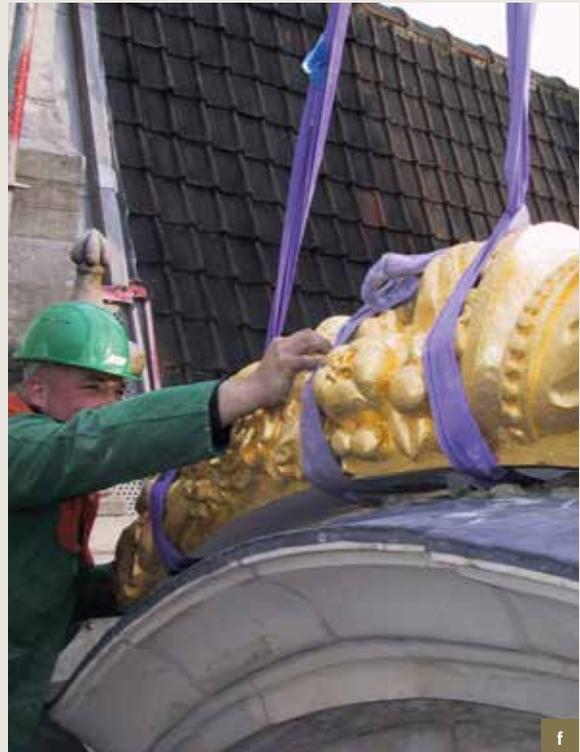
For example, the cornucopias at the apex of the Euville stone pediment on *L'Âne/Den Ezel* were replaced

with a stone of a similar nature due to the poor condition of the pieces. To do this, two large original pieces were dismantled and remodelled using plaster with the help of photos from the City of Brussels Archives. The new stones were then sculpted using the pointing method¹. These sculpted elements were gilded with gold leaf,² before being hoisted with a crane and carefully put back into place.

L'Âne/Den Ezel. Stages in the replacement of the cornucopias on the gable. a) Condition of Euville stone cornucopias before removal; b) The badly damaged cornucopias were repaired in the workshop using plaster and based on information from old photos. These pieces served as models for the new elements; c) New element made from Euville stone being sculpted using the pointing method; d) One of the finished elements; e) One of the elements gilded with gold leaf; f) Once finished, the cornucopias from the gable were hoisted with a crane and carefully put back in position (© HHU, 2003-2004).

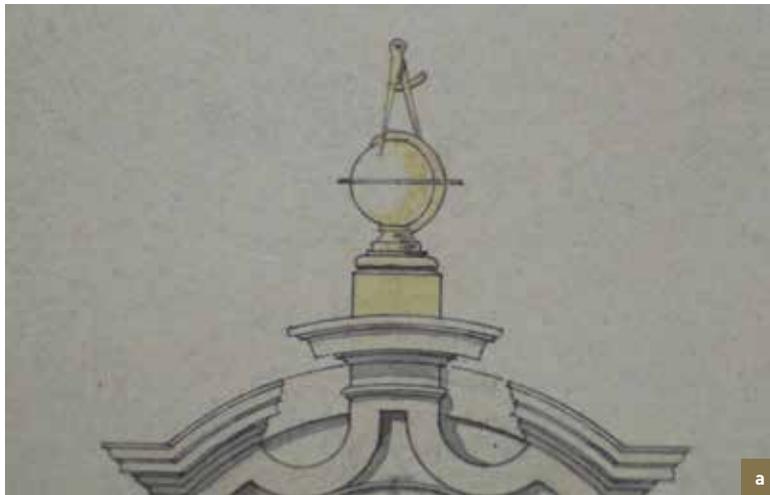
Le Sac/Den Sack. Globe. a) Archive drawing that was used for the creation of the new zinc globe, due to the existing globe being too badly damaged (© AVB); b) New gilded globe on the apex of the gable (© HHU, 2014-2015).

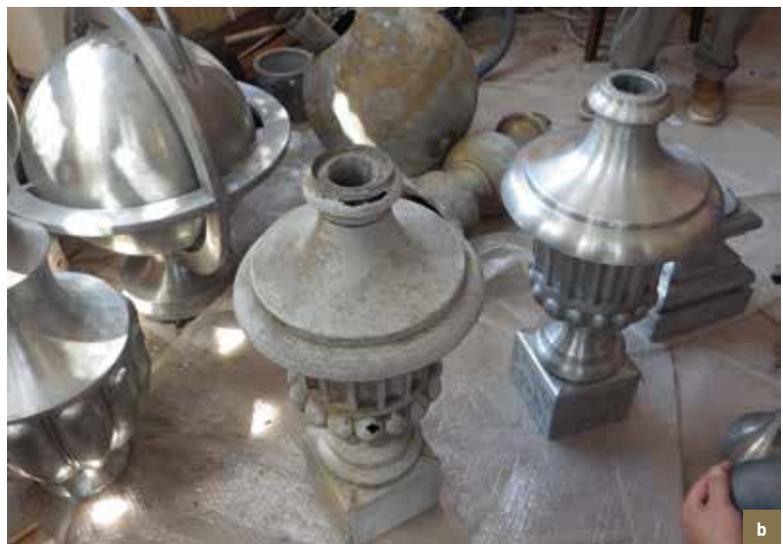
Le Sac/Den Sack. Zinc vase. a) Cracked and pockmarked original element; b) Old and new elements (© HHU, 2014-2015).

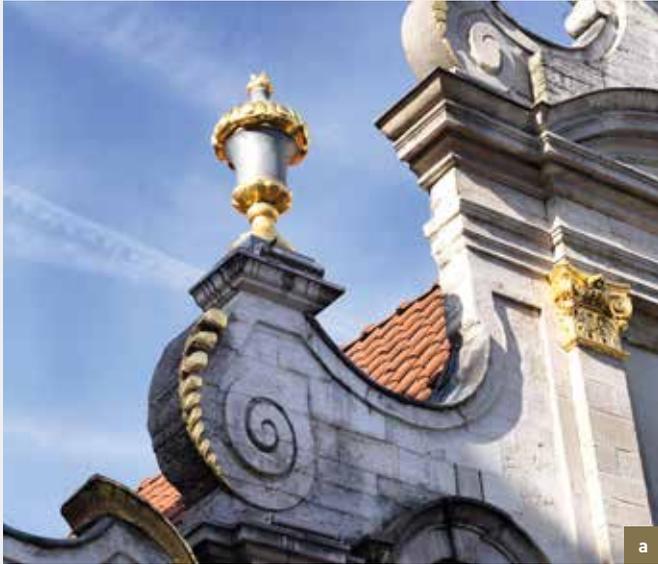
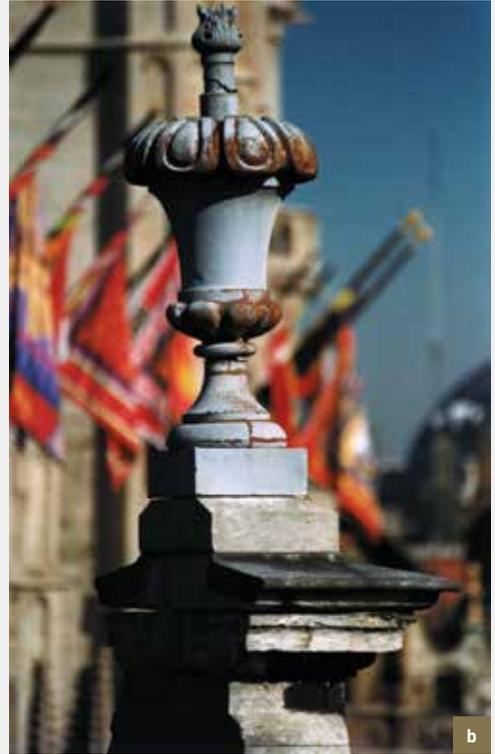
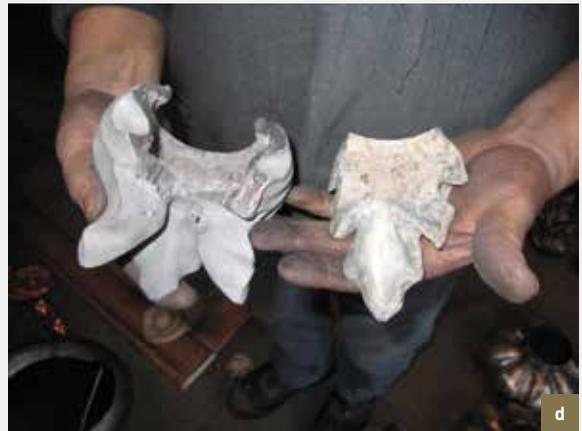
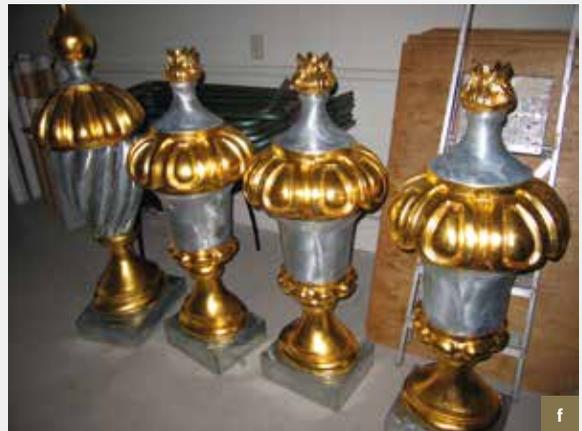
La Rose/De Roose. a) Partial view of the gable (© Utopix, M. Ploton, 2018); b) Detail of an original zinc vase; c), d) and e) Stages in the creation of a new vase in the workshop; f) The new gilded vases (© HHU, 2014-2015).

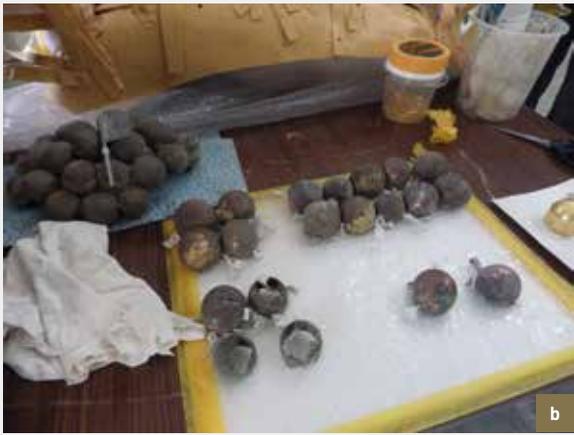
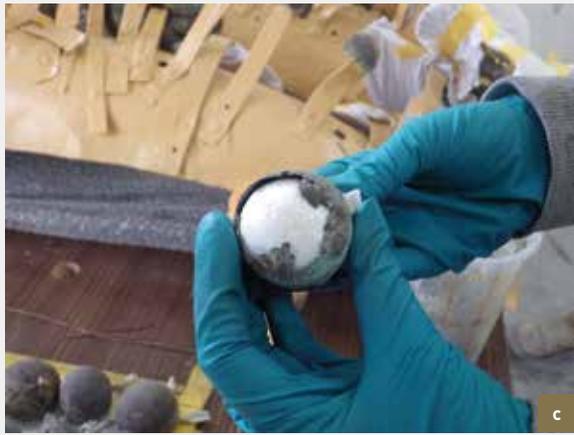
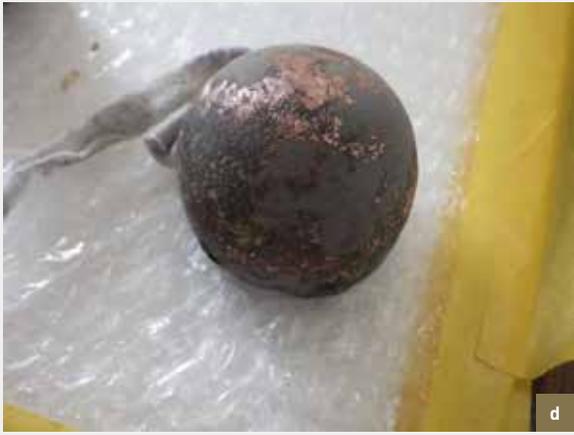
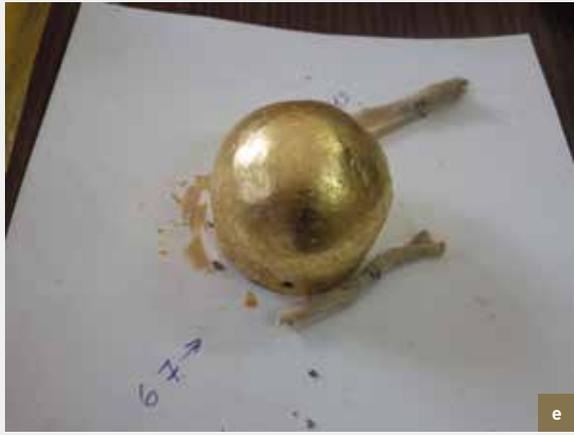
La Brouette/Den Cruywagen. Stages in the restoration of copper garlands. a) Condition before restoration (the bunches of grapes were badly corroded, some even having holes); b, c, d and e) Restoration in the workshop (with numbering), sanding with steel wool, cleaning with demineralised water and acetone, filling of holes (epoxy) and application of gilding (© HHU, 2014-2015).

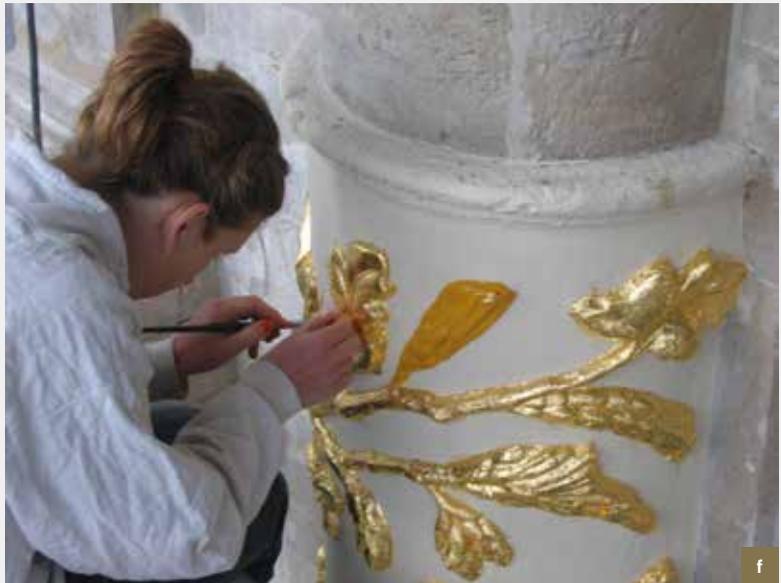
*La Maison des Brasseurs/Het Brouwerhuis. Column decorated with twisted foliage. a) The metal parts caused the element to crack or chip (cementing on original stone). Damaged state before casting and restoration; b) Core sampling of mortar; c) Moulding with silicone; d) Fibreglass-reinforced polyester resin shell; e) The cast is transported for possible reproduction; f) Finally, the elements were restored *in situ*, painted and gilded (© HHU, 2014-2015).*

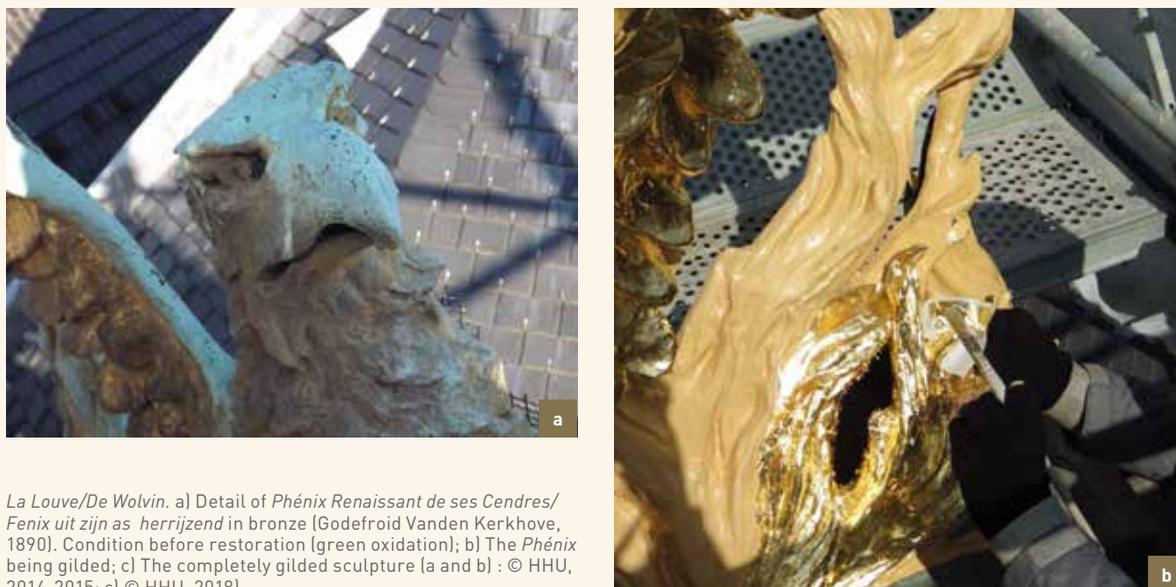
La Louve/De Wolvin. a) Detail of *Phénix Renaissant de ses Cendres/ Fenix uit zijn as herrizend* in bronze (Godefroid Vanden Kerkhove, 1890). Condition before restoration (green oxidation); b) The *Phénix* being gilded; c) The completely gilded sculpture (a and b) : © HHU, 2014-2015; c) © HHU, 2018).

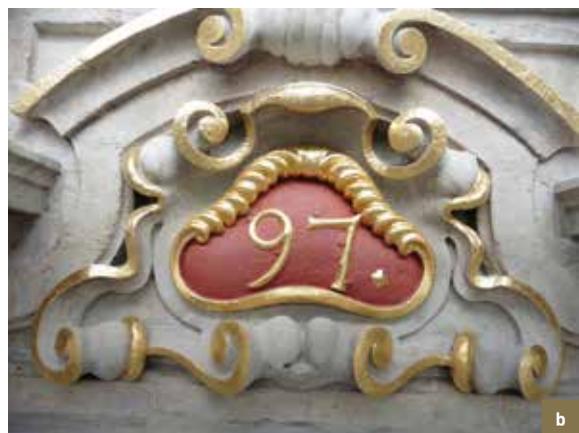
La Brouette/Den Cruywagen. Detail of medallions with date inscription. a) Medallion on the left before restoration; b) Medallion on the right after restoration (repairs to stones, colouring, gilding) (© HHU, 2014-2015).

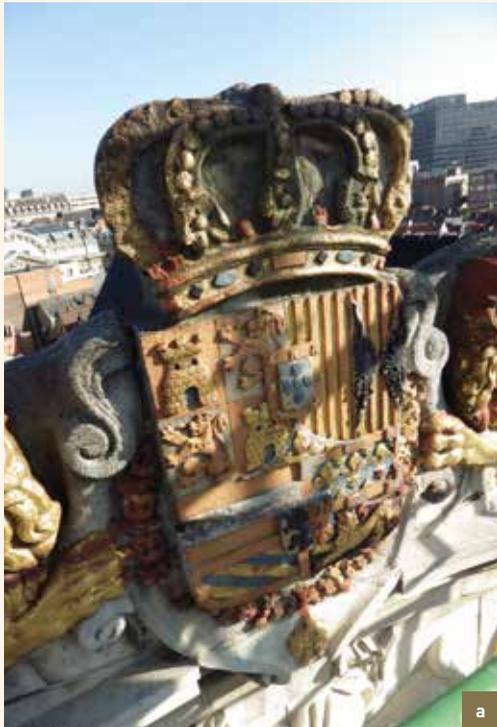
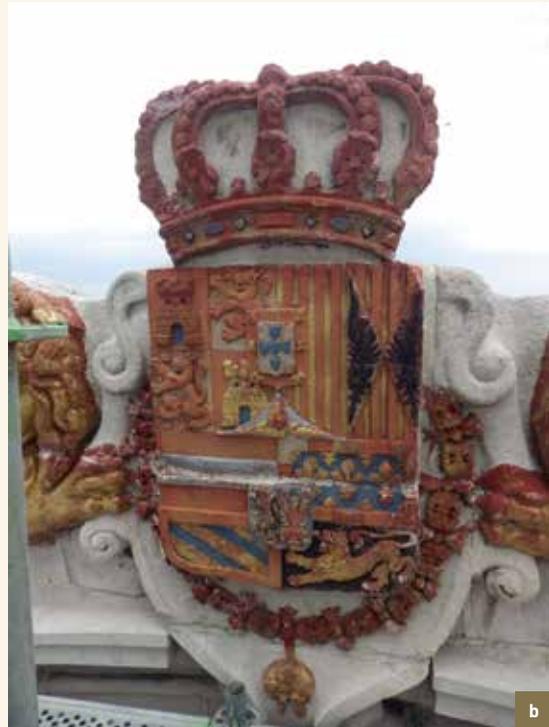
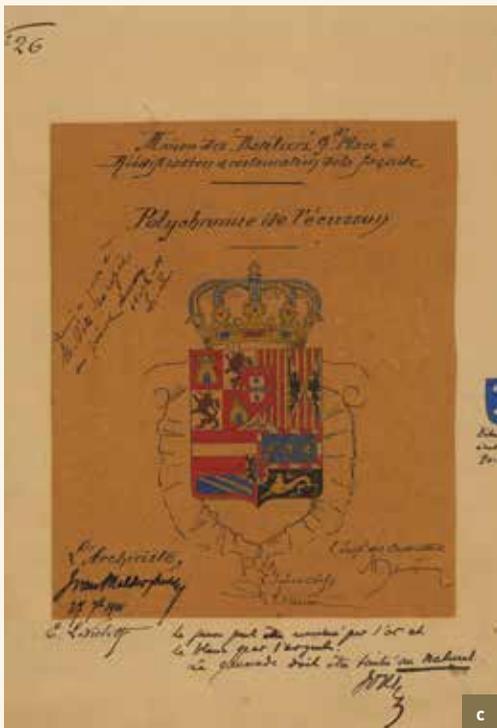
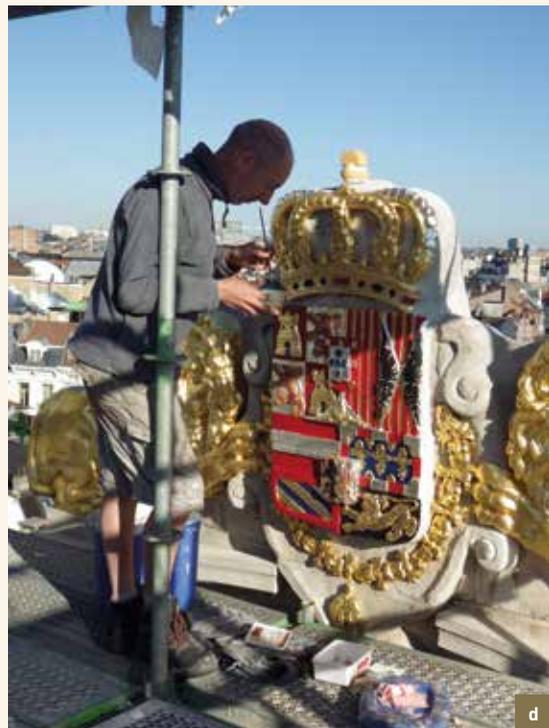
Le Cornet/Den Horen. Stages in the restoration of the polychrome coat of arms based on an original document. a) Before cleaning; b) After cleaning; c) Archive document indicating the precise pigments in the coat of arms; d) Restoration and repair of polychromy in progress; e) The piece when almost completed. Gilded areas and those in the process of being gilded, as well as sections covered with silver leaf, in accordance with the instructions in the original documents, can be seen beside the polychrome elements (© AVB and HHU, 2014-2015).
