BRUSSELS HERITAGE

La Grand-Place, Brussels
inscribed on the World
Heritage List in 1998

THE RESTORATION OF AN EXCEPTIONAL DECORATIVE ENVIRONMENT

THE RESTORATION WORKSITE 2004-2018

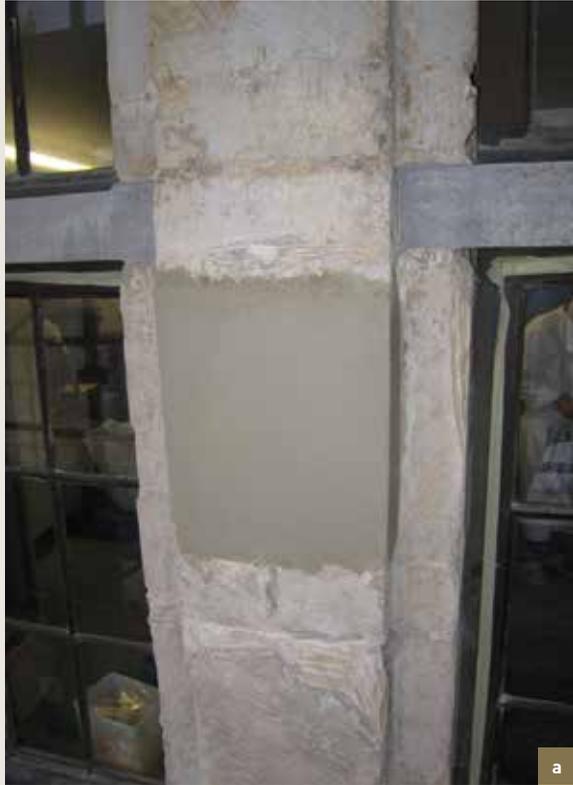
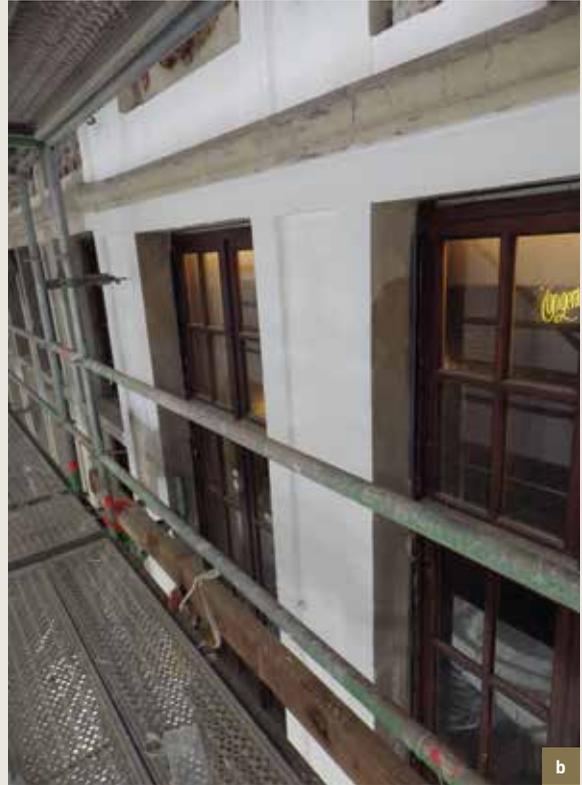
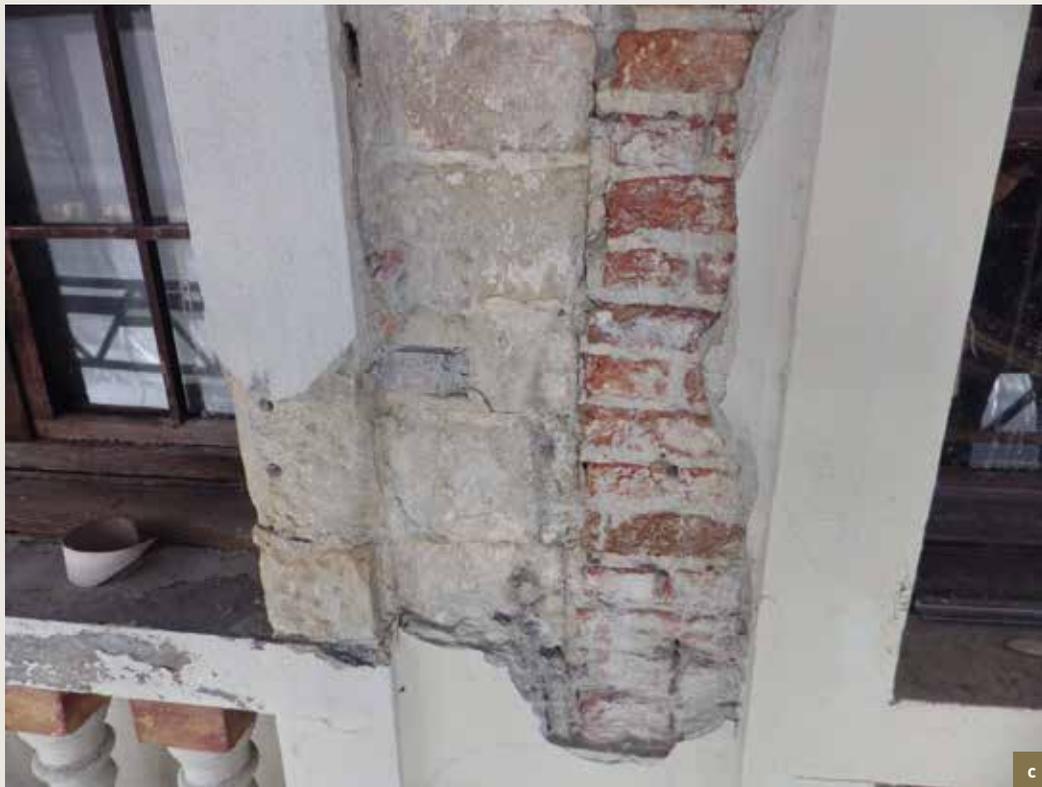
Coating of certain façades. a) *La Rose/De Roose*. Test coating; b) *Le Petit Renard et le Chêne/Het Vosken en Den Eycke*. Work in progress; c) *Le Petit Renard et le Chêne/Het Vosken en Den Eycke*. Removal of loose sections of render (© HHU, 2008 and 2015).
