BRUSSELS HERITAGE

La Grand-Place, Brussels
inscribed on the World
Heritage List in 1998

THE RESTORATION OF AN EXCEPTIONAL DECORATIVE ENVIRONMENT

THE RESTORATION WORKSITE 2004-2018

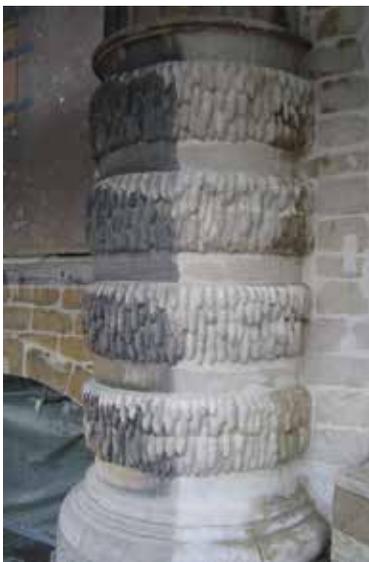
La Maison des Brasseurs/Het Brouwerhuis. Cleaning test. Detail of rustic bossages on columns. Balegem stone. Low pressure hydro-pneumatic swirling vortex technique (© HHU, 2004).

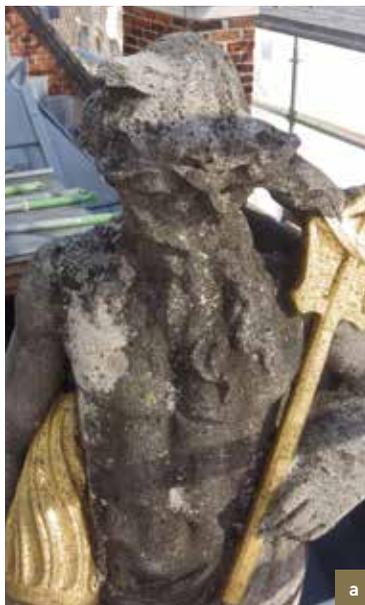
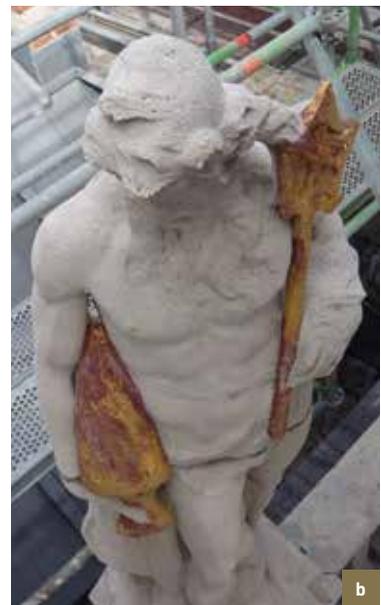
Le Roi d'Espagne/Den Coninck van Spanjien. Sculpture of *L'Eau - Neptune/Het Water - Neptunus* (Isodore De Rudder, 1898) decorating the balustrade, before (a) and after (b) cleaning. Euville stone (© HHU, 2014).

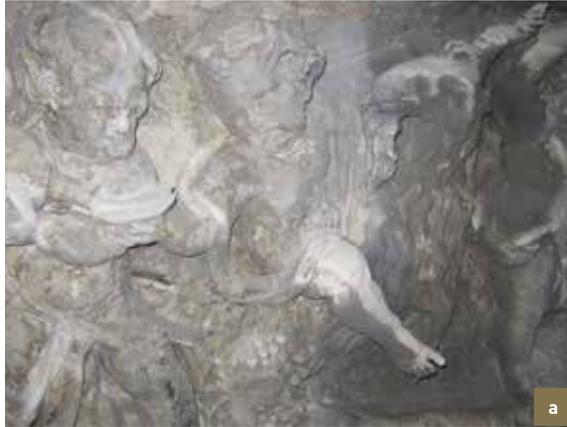
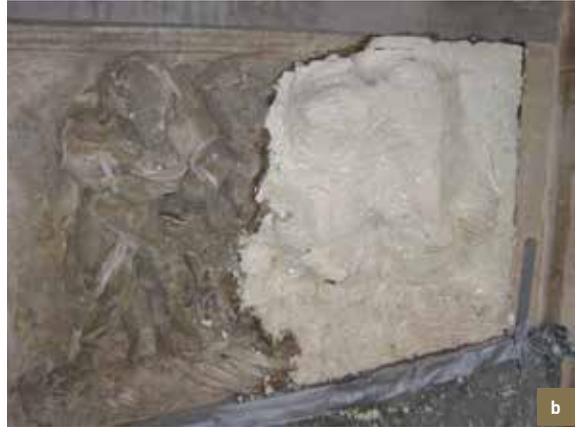
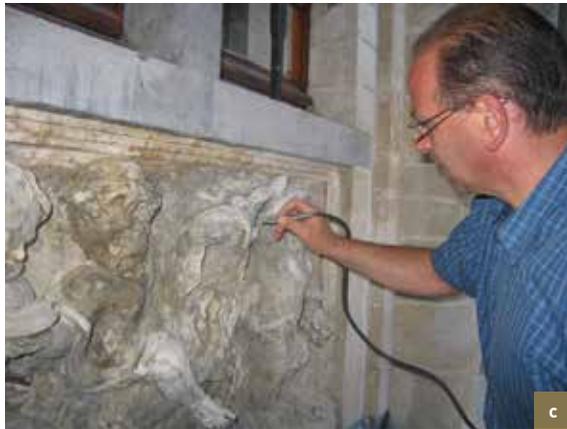
La Maison des Brasseurs/Het Brouwerhuis. Details of one of the apron panels on the 2nd floor depicting the harvest (Pierre Van Dievoet, 1698). Most likely Avesnes stone. a) Build-up of dirt on sculpted putti prior to restoration, with partial cleaning on the left; b) Application of compresses composed of an ammonia-based cellulose paste to soften the black crust; c) Finalising cleaning using a micro-sandblaster; d) Condition after cleaning (© HHU, 2004).

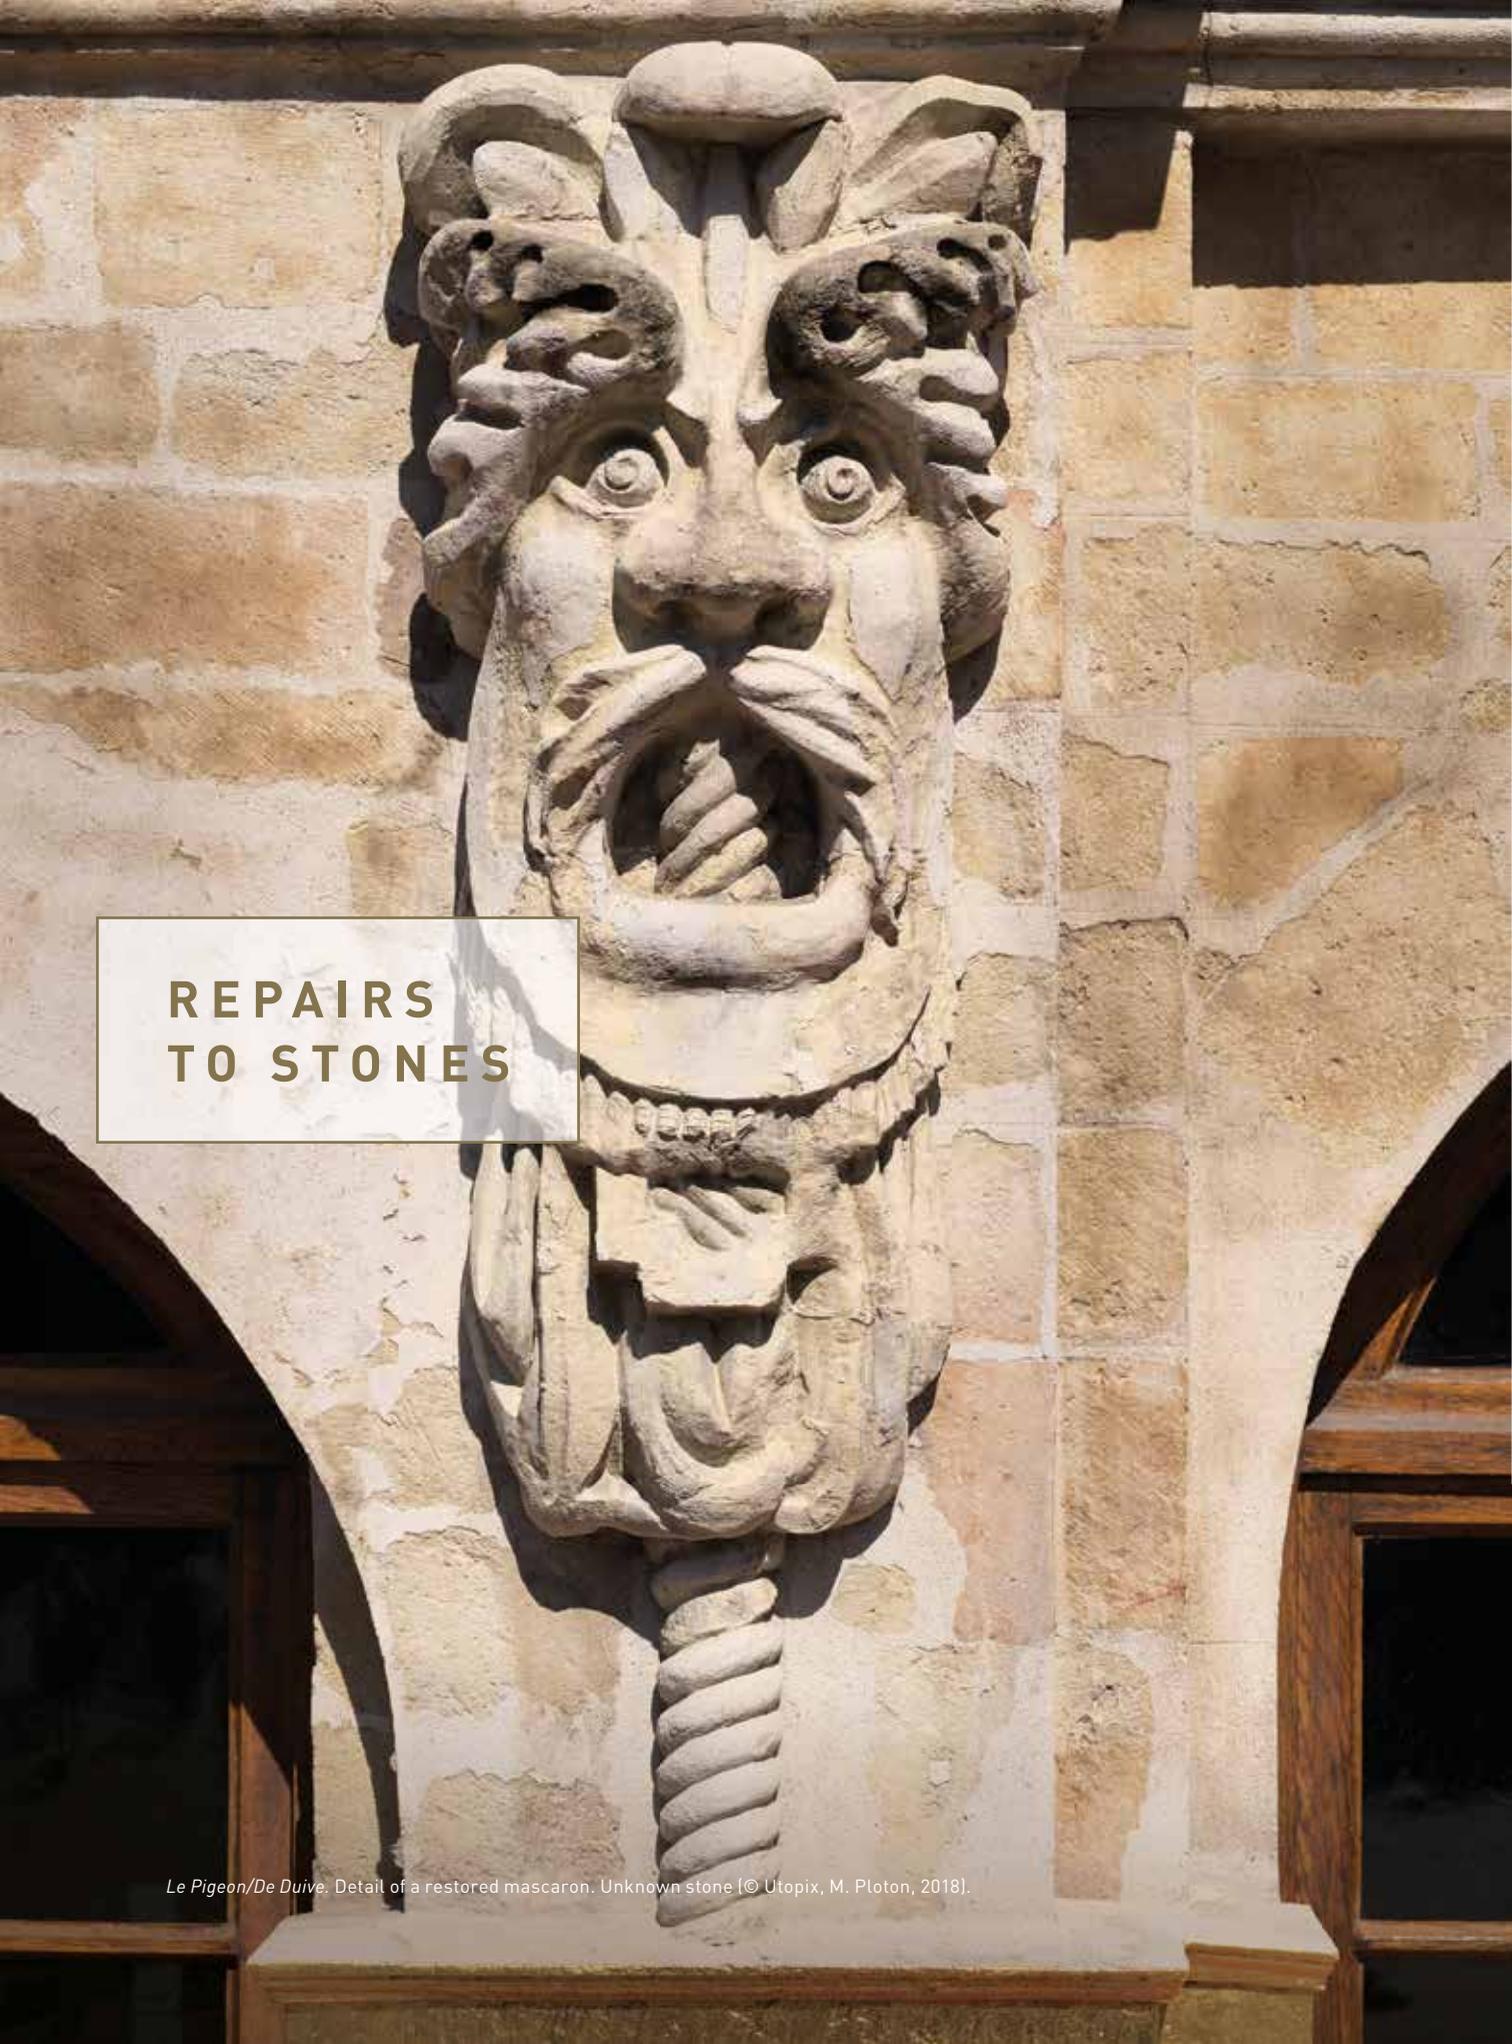
Le Pigeon/De Duive. Detail of a restored mascaron. Unknown stone [© Utopix, M. Ploton, 2018].

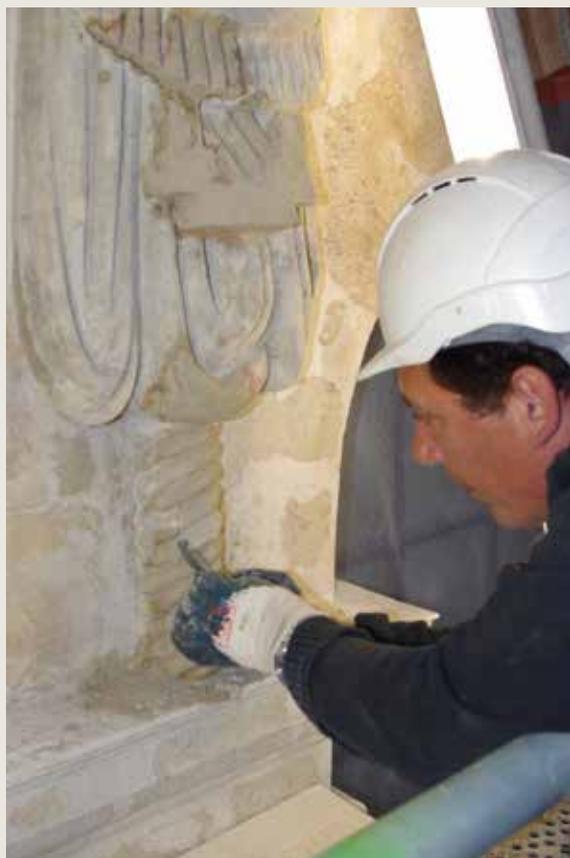
Le Pigeon/De Duive. Restoration in progress with smoothing mortar (twisted element of the mascarón). Unknown stone (© HHU, 2012).

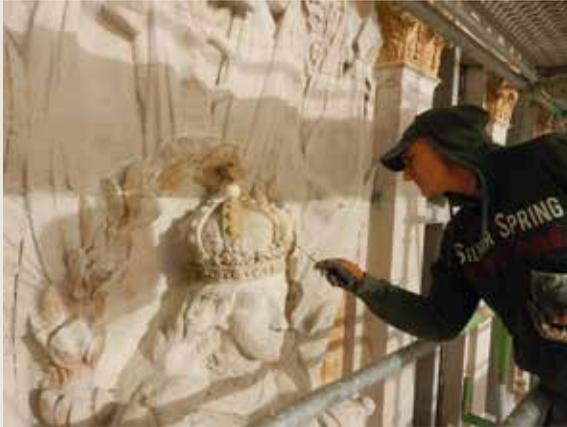
Le Roi d'Espagne/Den Coninck van Spaignien. Detail of bas-relief depicting the *Trophée de Charles II/Trofee van Karel II*. Repairwork on the crown in progress. Smoothing mortar and Euville stone (© HHU, 2014).

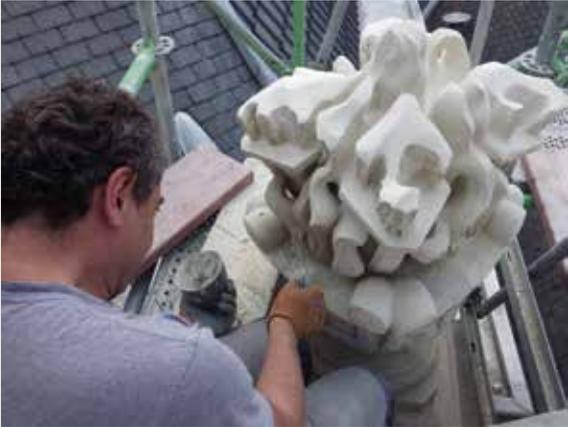
La Louve/De Wolvin. Flame finial on the pediment undergoing repair. French stone (© HHU, 2014).

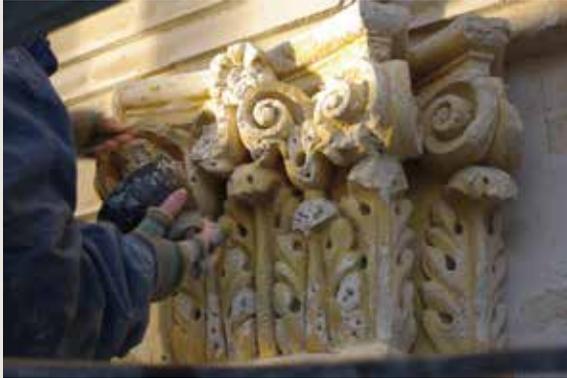
Le Pigeon/De Duive. Detail of two capitals undergoing repair. Unknown stone (© HHU, 2012).

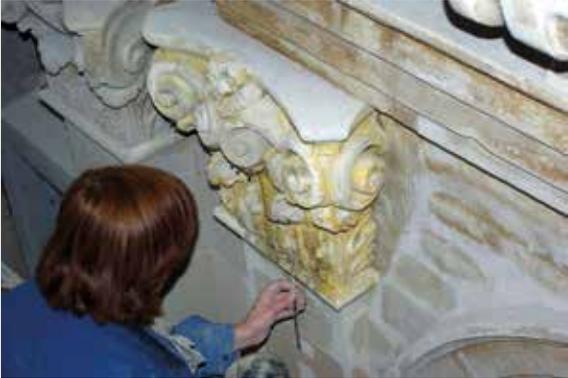
L'Ange/Den Engel. Capital undergoing restoration. Euville stone (© HHU, 2012).

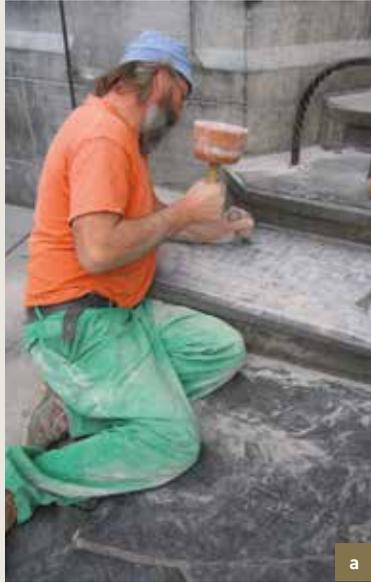
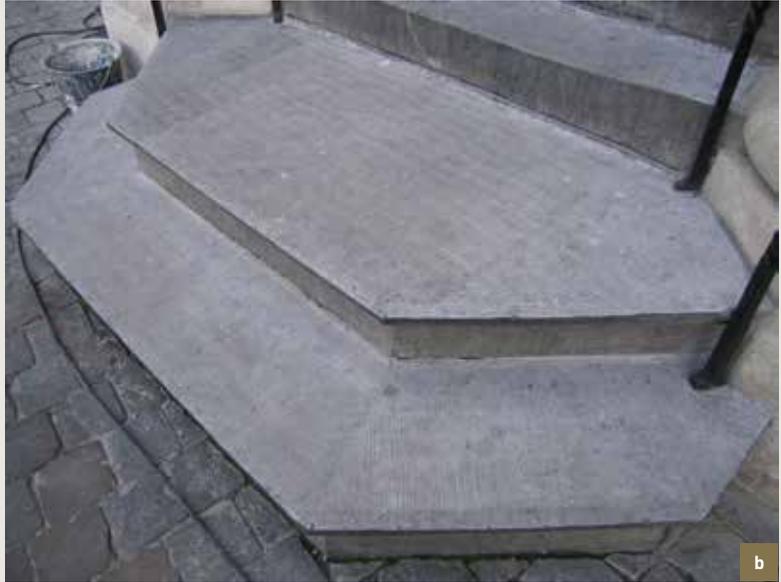
Le Cygne/De Swane. a) Chiselling of entrance steps in progress, based on the existing model. Blue stone; b) Finished job (© HHU, 2008).

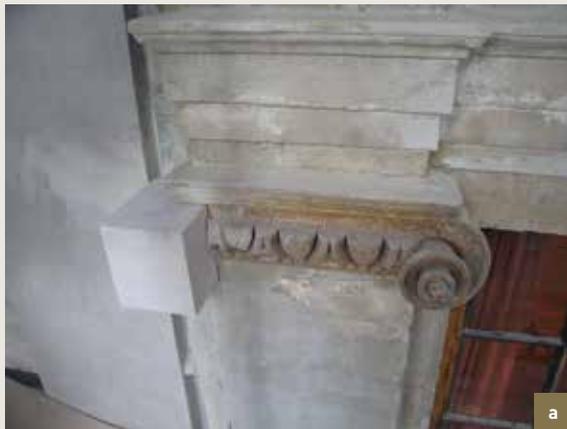
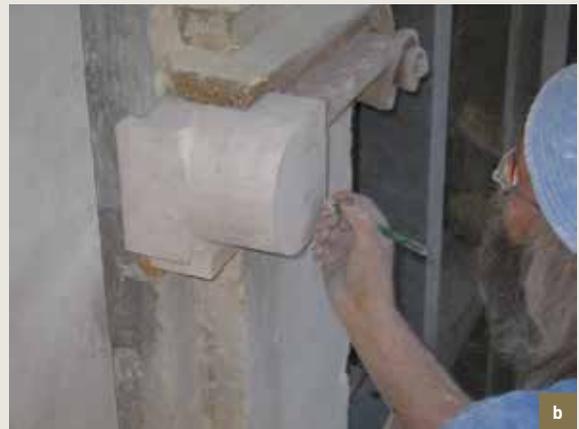
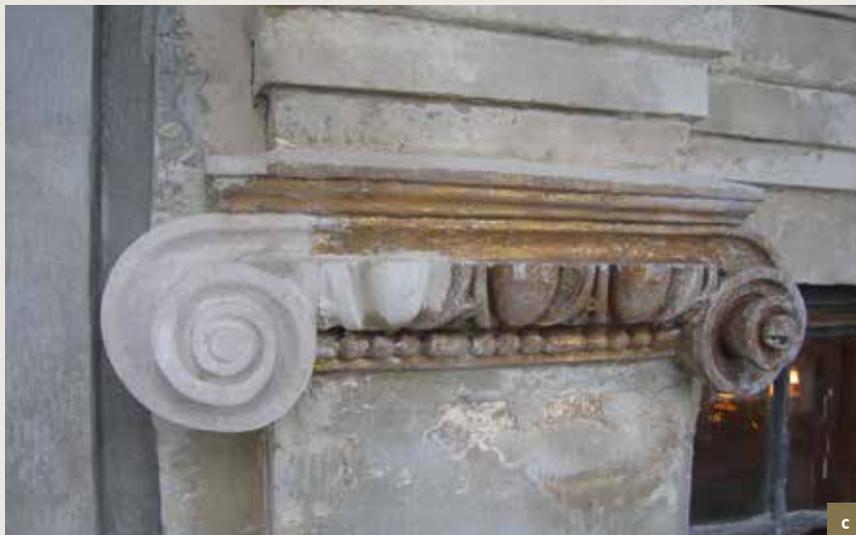
La Rose/De Roose. First floor, volute on a capital undergoing restoration: a) Integration of a Massangis stone graft; b) Sculpting in progress; c) Finished element (© HHU, 2008).

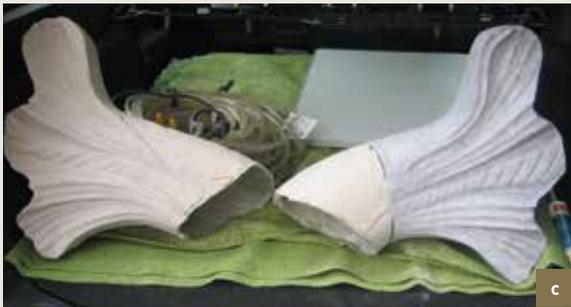
La Maison des Brasseurs/Het Brouwerhuis. Detail of the blue stone dolphins on the gable. a) On the left, blue stone dolphin being used as a model for the missing element on the dolphin on the right; b) On the right, dolphin with missing tail fin; c) Cast of the tail fin of the dolphin on the left and new blue stone element to be used to repair the dolphin on the right. Cast made from fibreglass-reinforced polyester resin and new blue stone sculpture; d) The new blue stone element fitted to the dolphin on the right (© HHU, 2008).

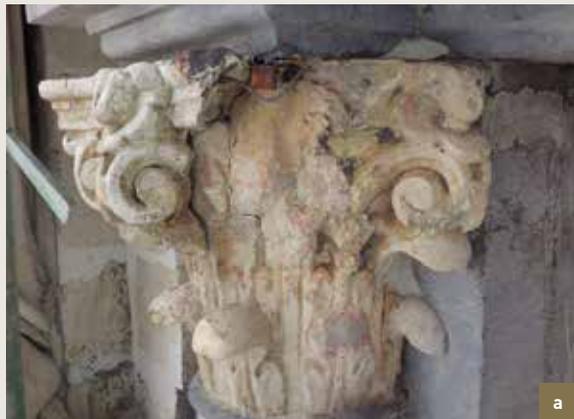
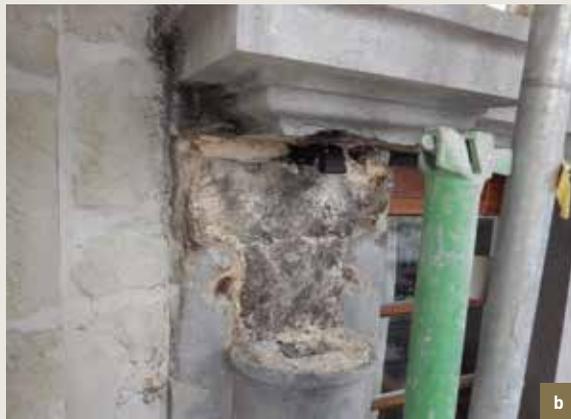
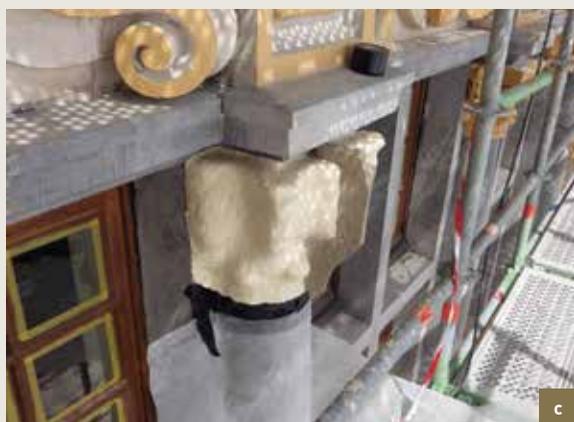
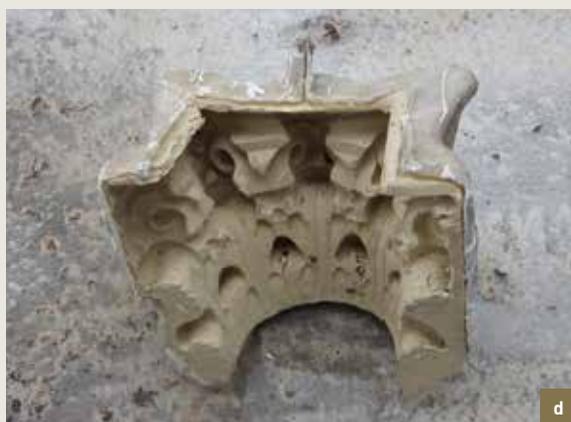
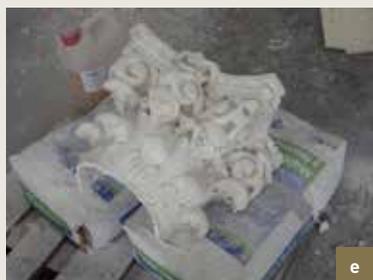
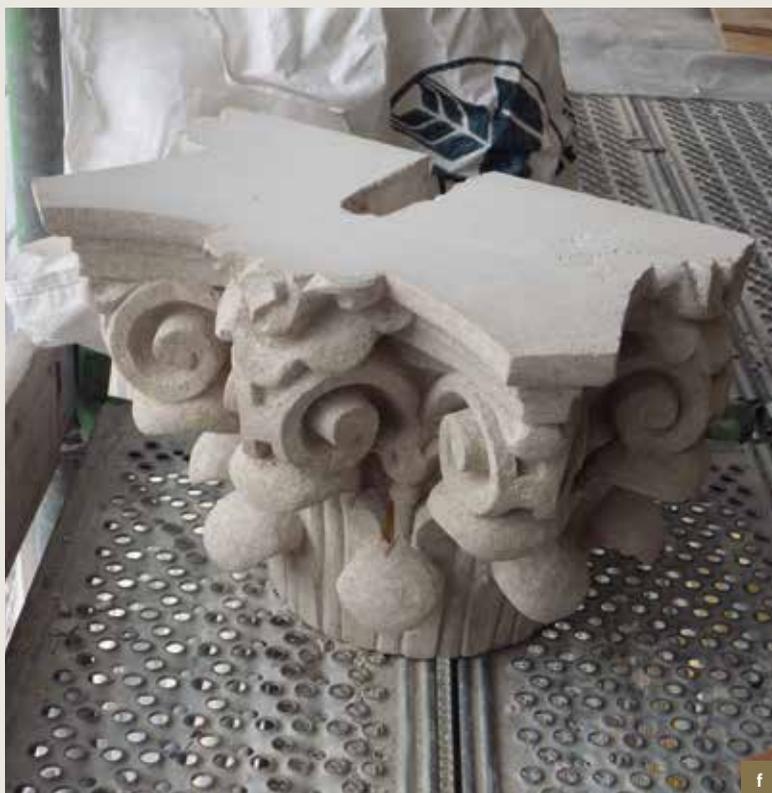
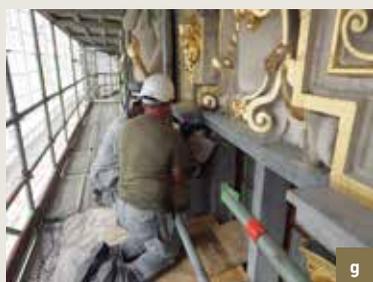
Le Sac/Den Sack. Stages in restoring a capital: a) Damaged condition; b) Removal of element; c) Moulding of a capital in good condition; d) Silicone mould with fibreglass-reinforced polyester shell; e) Plaster positive; f) New sculpture made from Savonnière stone; g) Integration of the stone element (© HHU, 2014-2015).

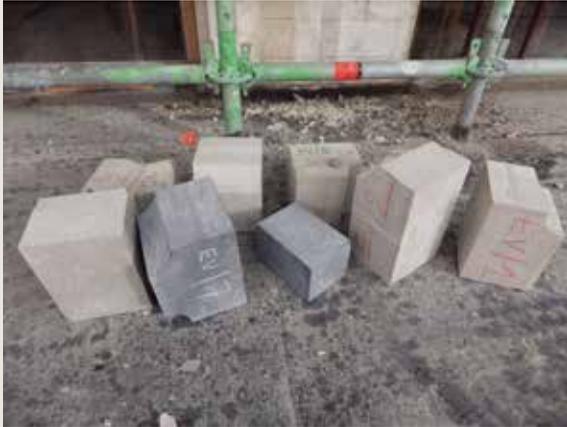
New stones delivered to the worksite to carry out the repairs required as a result of the chipping of stones due to corroding metal elements. Gobertange stone and blue stone (© HHU, 2015).

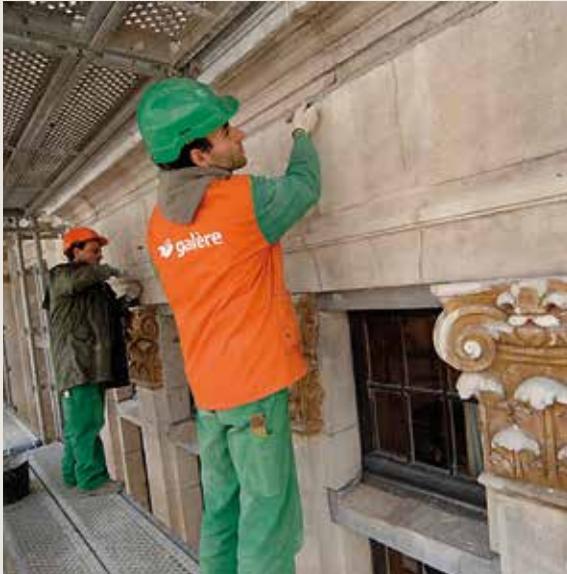
L'Étoile/De Sterre. Repointing with mortar (© Daylight, 2008).

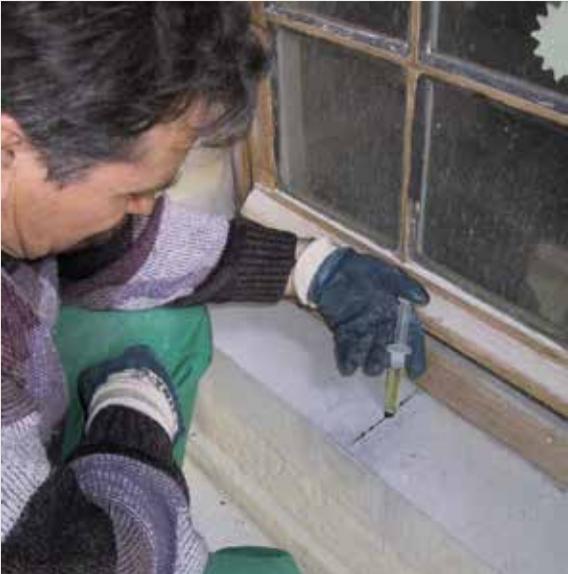
L'Âne/Den Ezel. Blue stone threshold. Injection of product (two-component epoxy) via small holes prepared for this purpose (© HHU, 2003-2004).

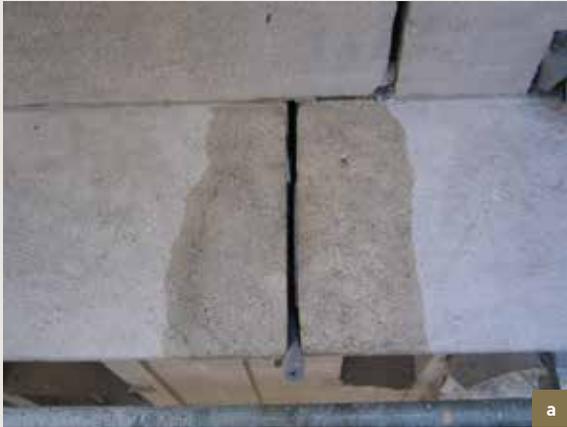
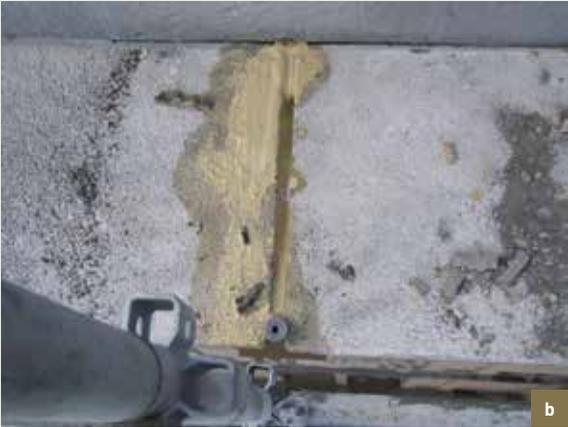
L'Étoile/De Sterre. a and b) Injection of grout (© HHU, 2008).

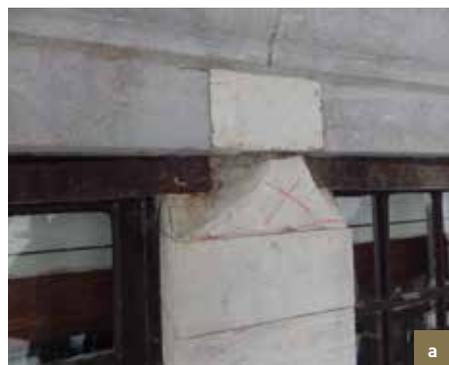
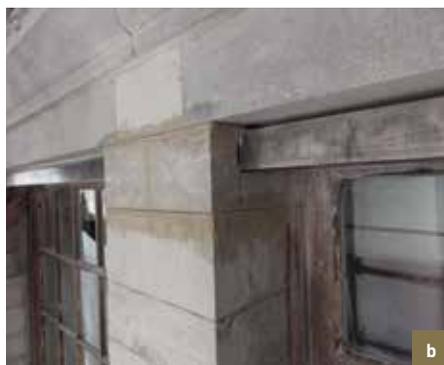
Sainte-Barbe/Sint Barbara. a) Detail of the stone to be replaced, marked with a cross using red chalk; b) New Gobertange stone elements and stainless steel bars (© HHU, 2015).

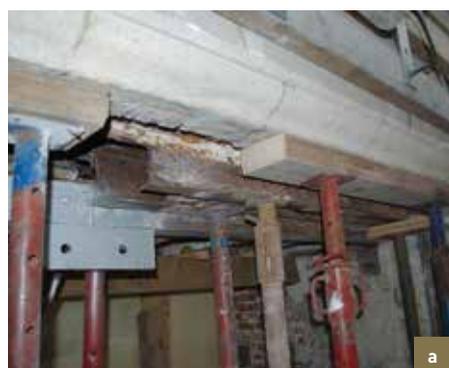
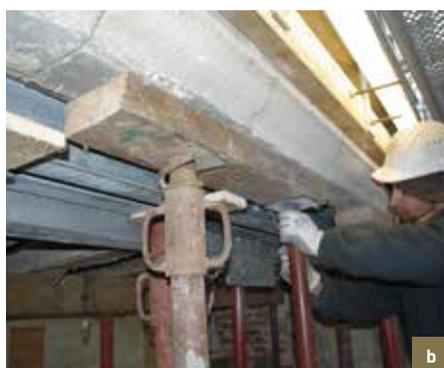
Le Cerf/ De Heert. a) Shoring of Euville masonry and fitting of metal clamp in order to remove the corroded metal beams; b) Installation of new galvanised steel beams (© HHU, 2008).

The metal girders were replaced with new elements made from stainless or, on a case-by-case basis, galvanised steel, and the stones were reassembled with staples, also made from stainless steel, by means of chemical anchoring.

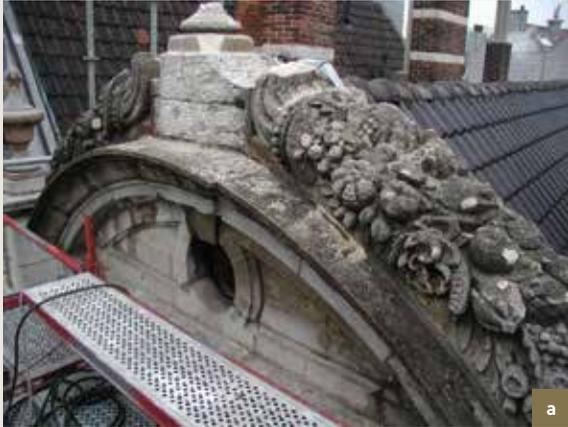
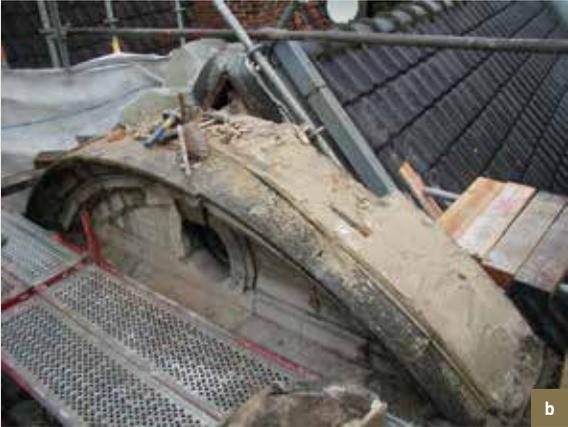
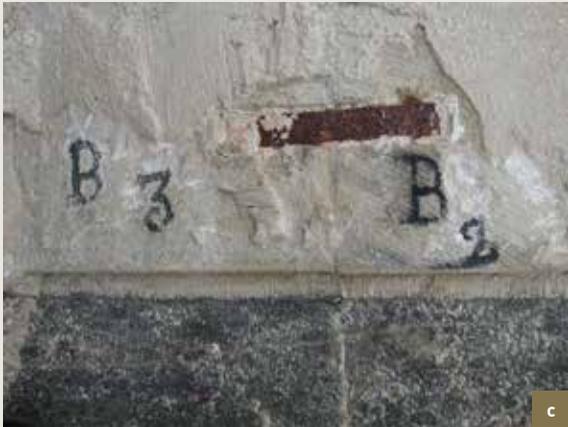
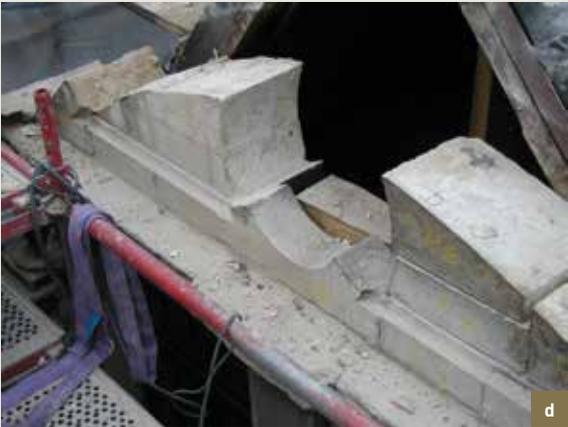
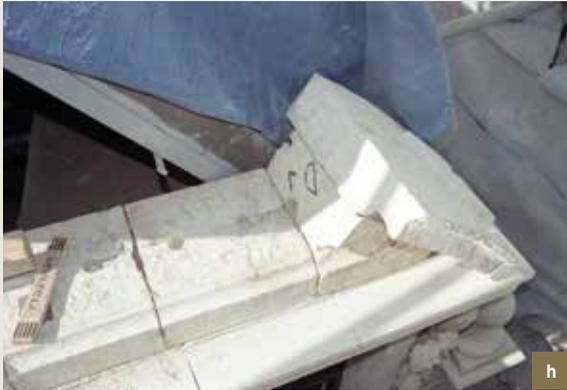
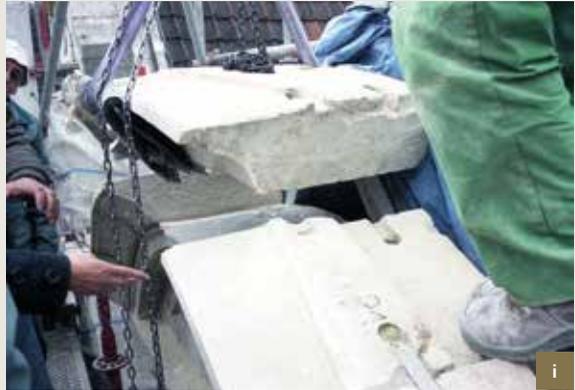
L'Âne/Den Ezel. Stages in the restoration of the arched pediment, from pre-restoration condition to complete reassembly. Euville stone. a) Damaged condition; b) Disassembly in progress; c) Old numbering of stones and corroded staple; d) New marking of stones prior to disassembly; e) Removal of corroded metal beams; f) Replacement of metal beams; g) Cleaning and restoration of stones in workshop; h) and i) Reassembly of restored elements; j) General view after these operations (© HHU, 2003-2004).

The different stones were assembled using metal staples sealed in lead. These elements were cut during dismantling to avoid damaging the stones. The stones were removed up to the corroded metal girders, the cause of the damage, so that they could be replaced. The elements that were dismantled were then transported to a workshop for restoration or replacement. The elements that were retained were

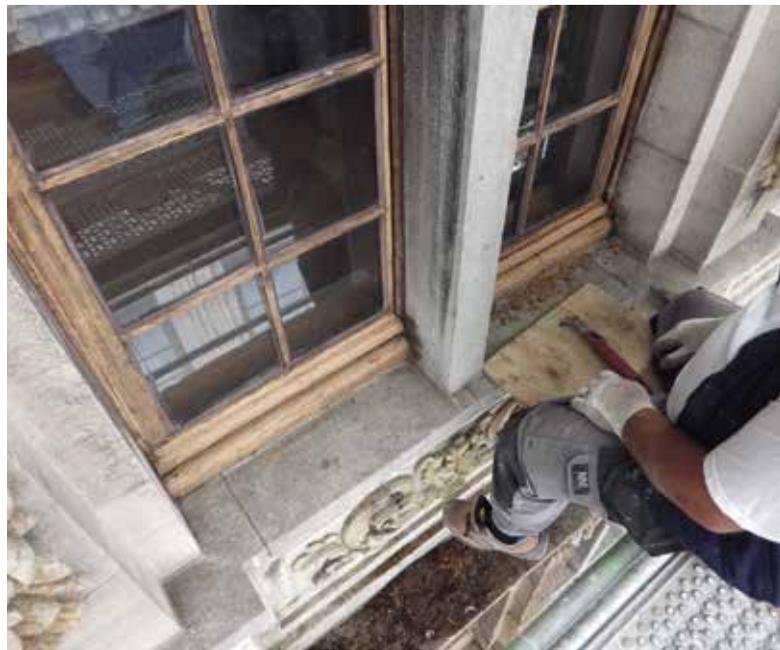
La Brouette/Den Cruywagen. Stripping window frames by hand. Oak wood (© HHU, 2014).

The window frames were stripped by hand using an abrasive product. Ad hoc repairs were carried out using grafts of wood of the same type (the replacements mainly concerned the weatherboards and sills). A brown-coloured varnish was applied to the entire frame based on the results of stratigraphic sampling. After repair work, the putty was painted the same colour as the woodwork.

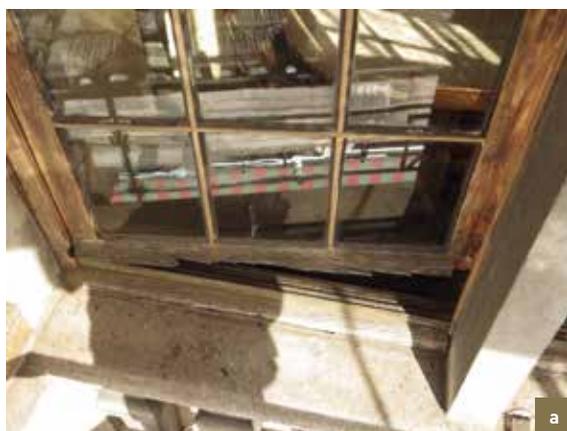
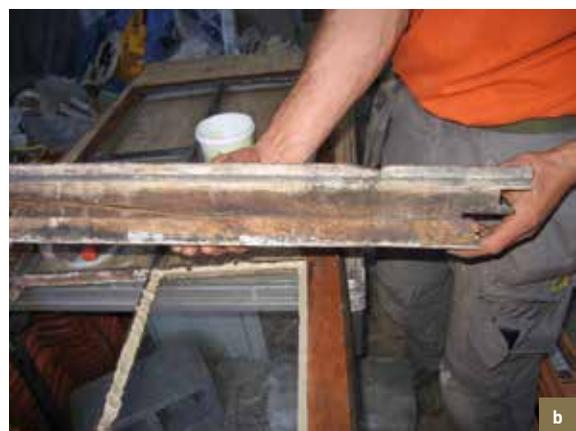
La Rose/De Roose. Damaged oak wood pieces. a) A weatherboard (lower part of window frame) requiring replacement; b) A window sill requiring replacement (© HHU, 2014).

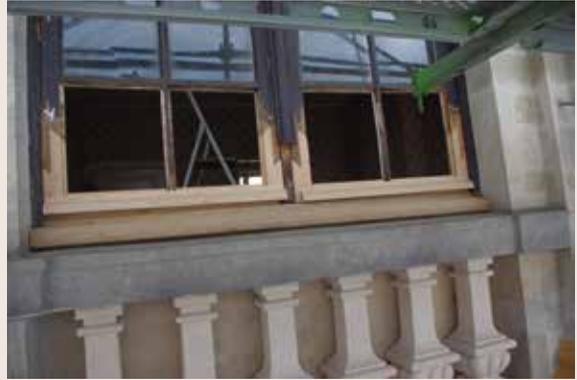
Le Pigeon/De Duive. Replacement of sill and weatherboard and fitting of grafts. Oak wood (© HHU, 2008).

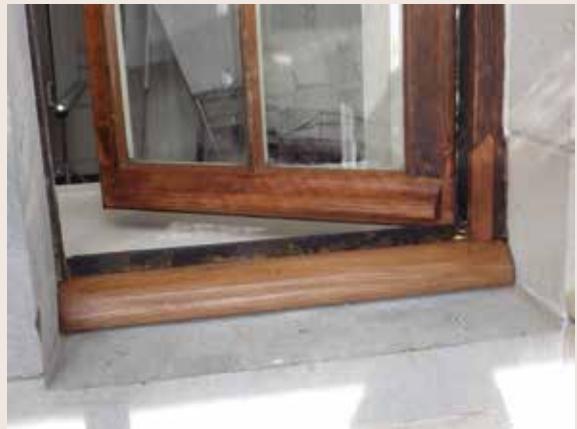
Restored window frame. Oak wood (© HHU, 2015).

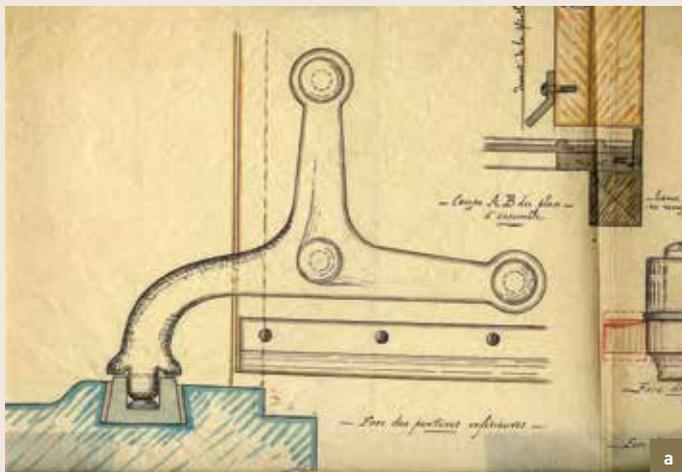
Le Cygne/De Swane. Restoration of cellar doors with their hinges. a) Archive drawing used to manufacture new hinges; b) Oak door in place. Presentation of resin mock-up of the hinges for approval of the model (© HHU, 2008 and AVB).

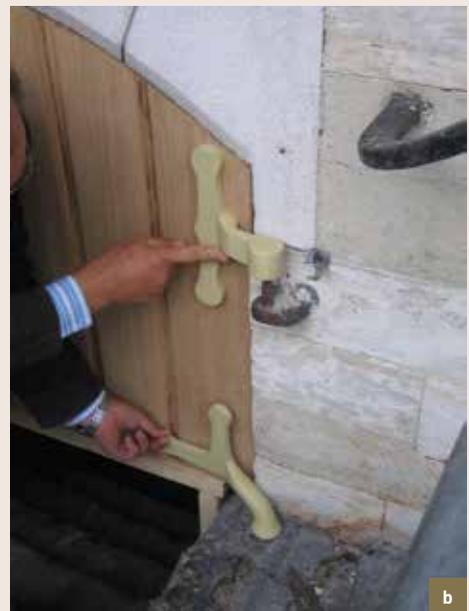
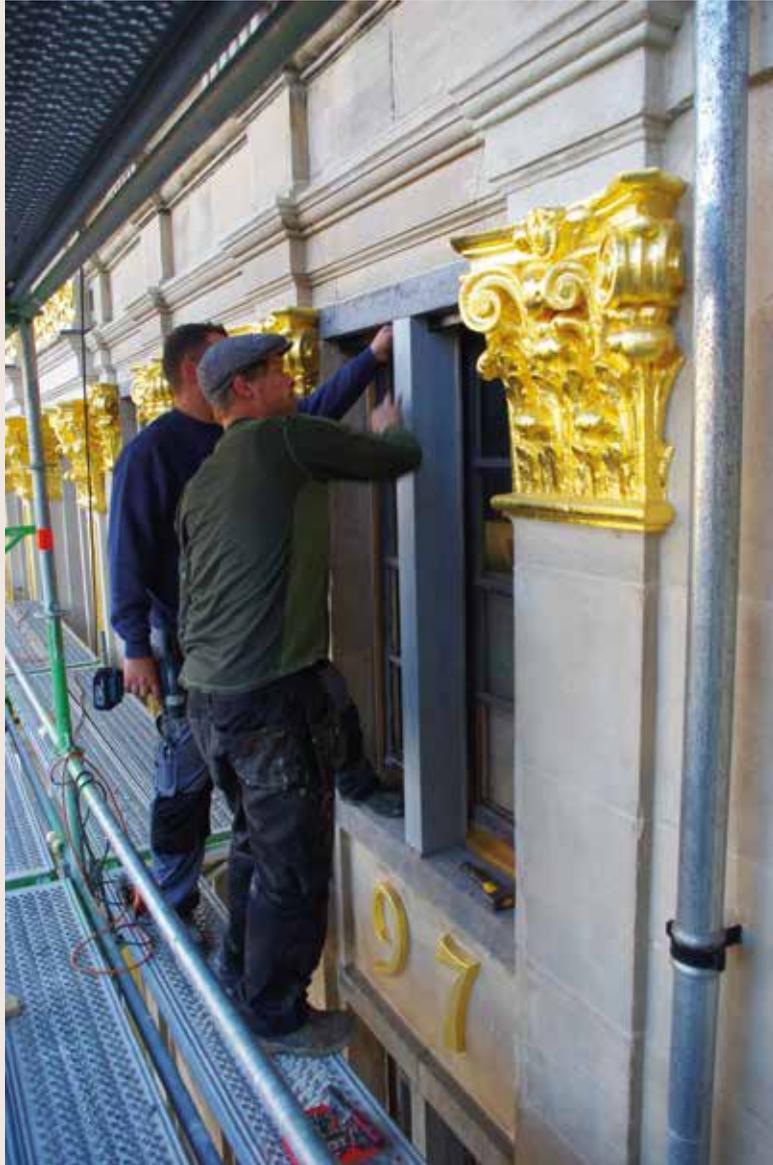
L'Ange/Den Engel. Installation of imitation blue stone mullions made of wood. They can be dismantled to facilitate removals (© HHU, 2008).

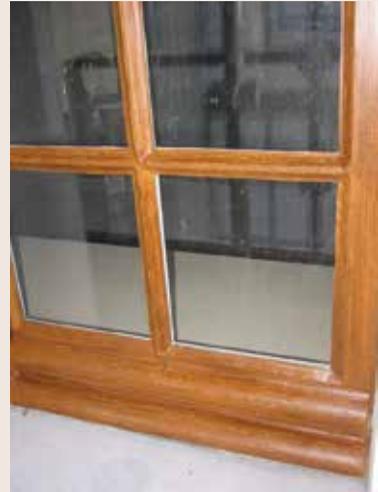
Le Cygne/De Swane. Certain non-oak frames were painted in imitation oak (© HHU, 2008).

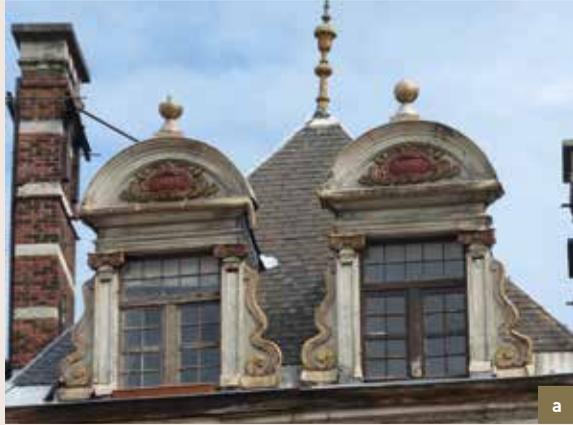
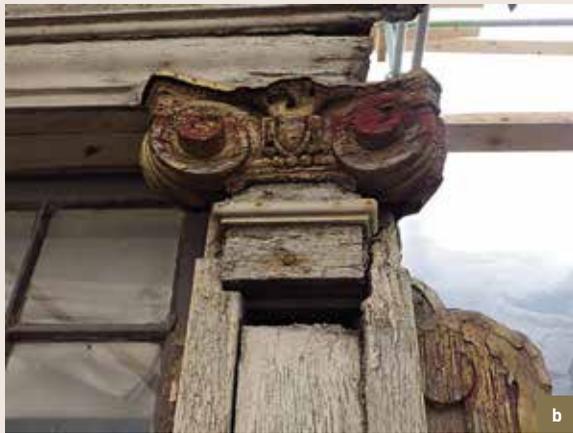
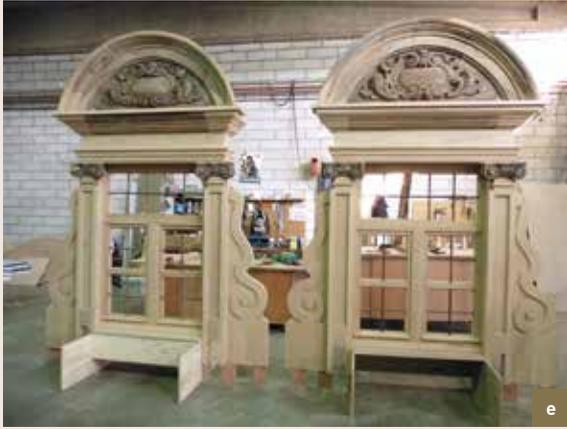
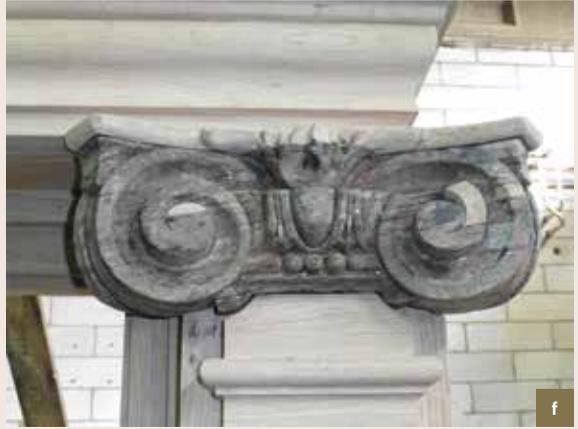
Le Petit Renard et le Chêne/Het Vosken en Den Eycke: Restoration of two oak dormer windows. a) Windows before restoration work; b) and c) Damaged wood and lead flashing, cracks, flaking paint and gilding; d) Archive drawing; e) Restoration in workshop with reinforcement of consoles and integration of grafts, replacement of parts that were too badly damaged; f) consolidation of a capital with insertion of grafts (© HHU, 2016 and AVB).

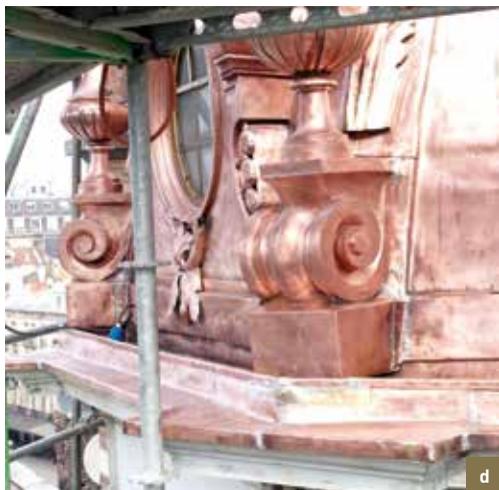
The copper cupola of the *Roi d'Espagne/Den Coninck van Spaignien* was dirty and had gradually assumed a natural green patina. An inspection revealed problems with the welding. All the copper elements were thoroughly sandblasted in order to expose and restore the copper.

Le Roi d'Espagne/Den Coninck van Spaignien. Stages in the restoration of the copper cupola. a) Condition of cupola before restoration with dirt and green patina; b) and c) Sandblasting in progress to expose and restore the copper in order to replace damaged parts and repair defective welding, among other things d) Cleaning and polishing using steel wool (© HHU, 2015).

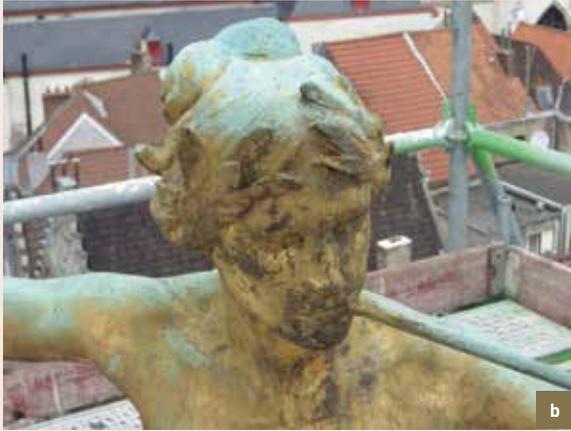
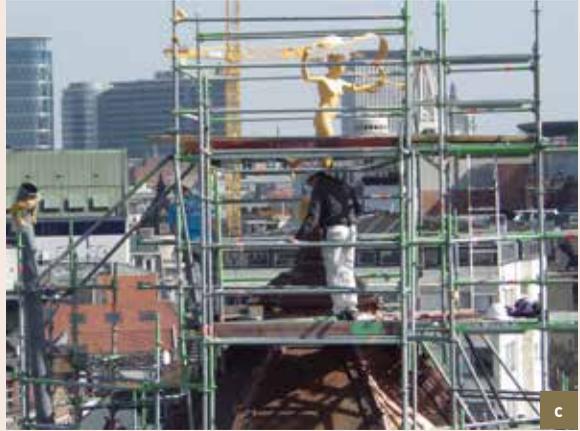
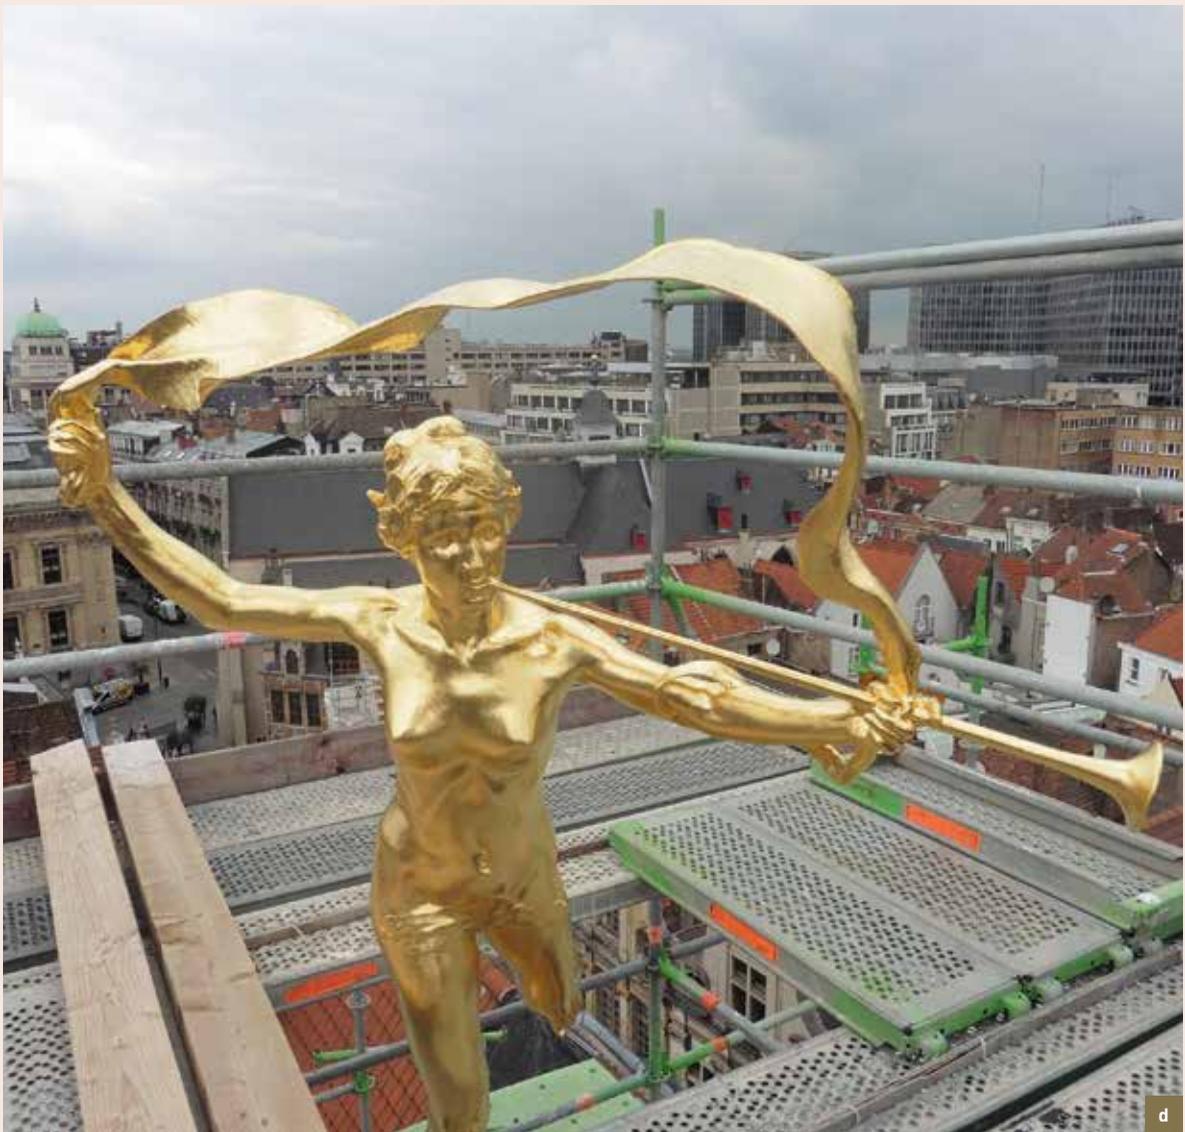
Le Roi d'Espagne/Den Coninck van Spaignien. Stages in the restoration of the bronze statue of *La Renommée/De Faam* (or *La Fortune/Het Fortuin*, Paul Du Bois, 1902). a) *La Renommée/De Faam* after restoration; b) Detail of the head of the statue before cleaning; c) Statue being painted (preparatory base layers for gilding); d) Gilded statue (© HHU, 2014-2015).

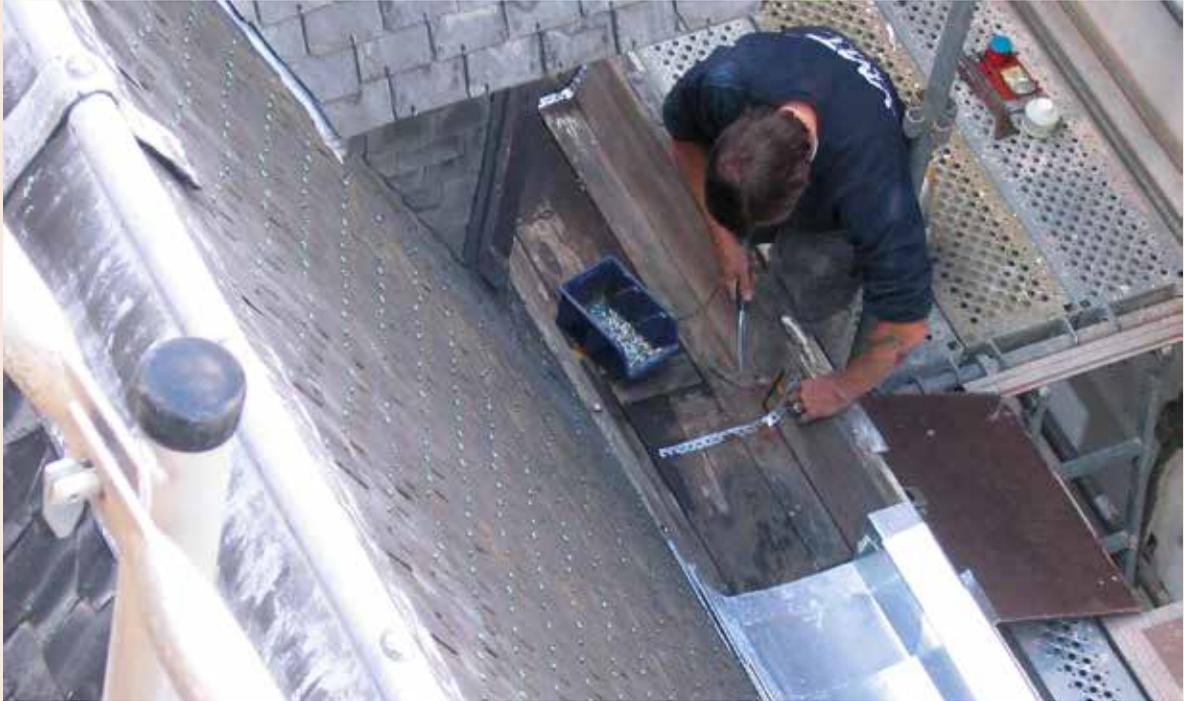
L'Étoile/De Sterre. Zinc cornice undergoing restoration (© HHU, 2008).

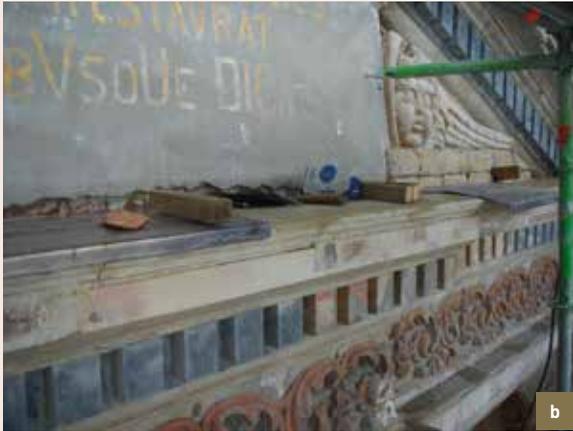
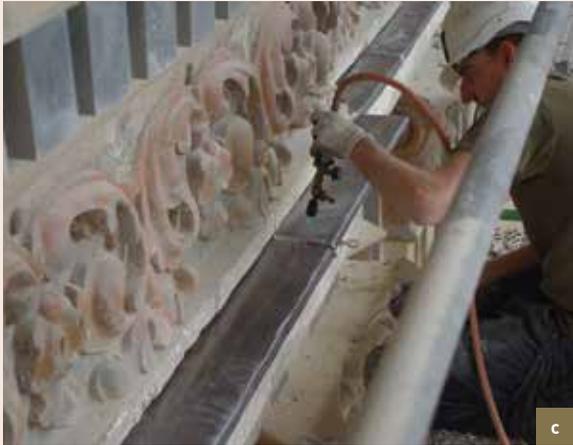
La Chaloupe d'Or/De Gulden Boot. a) Overview of restored pediment, with the zinc denticles of the entablatures and the lead flashing on projecting elements (© Utopix, M. Ploton, 2018); b) Detail of the zinc denticles and lead flashing during installation; c) Idem. Welding in progress (© HHU, 2008).

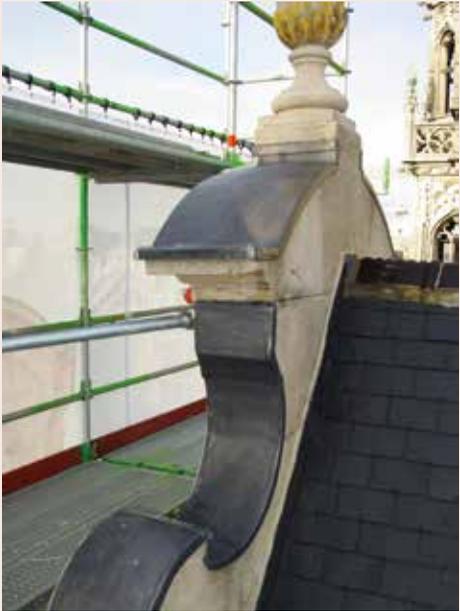
Aux Armes de Brabant/De Wapens van Brabant. Restored lead on parts of gable exposed to rainwater runoff (© HHU, 2008).
