BRUSSELS HERITAGE

La Grand-Place, Brussels
inscribed on the World
Heritage List in 1998

THE RESTORATION OF AN EXCEPTIONAL DECORATIVE ENVIRONMENT

THE RESTORATION WORKSITE 2004-2018

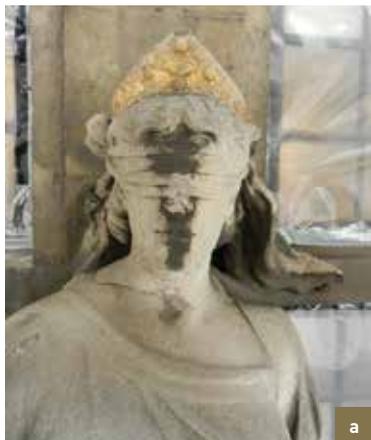
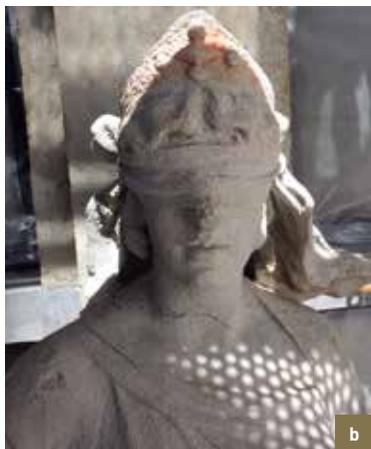
Le Renard/De Vos. Detail of the statue *La Justice/Justitia* (Pierre Comein, 1884). Euville stone. a) Before cleaning. Build up of dirt, peripheral crack on head; b) After cleaning; c) After the restoration of the stone (securing of the cracked head, patching with mortar using photographs of models) (© HHU, 2014-2015).

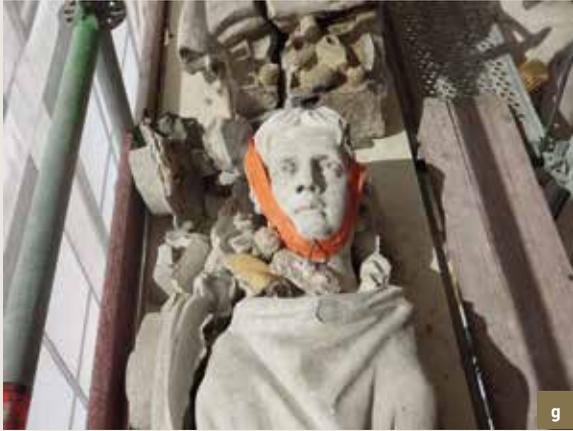
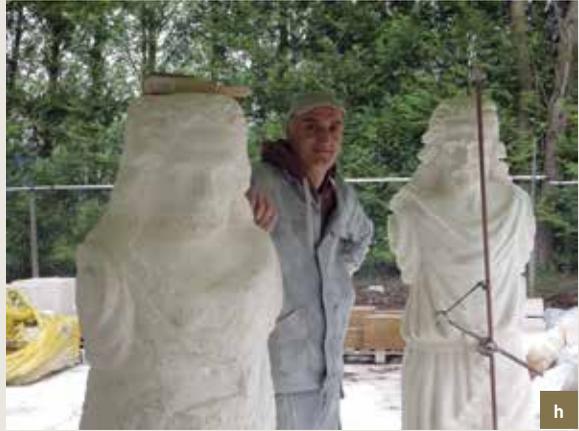
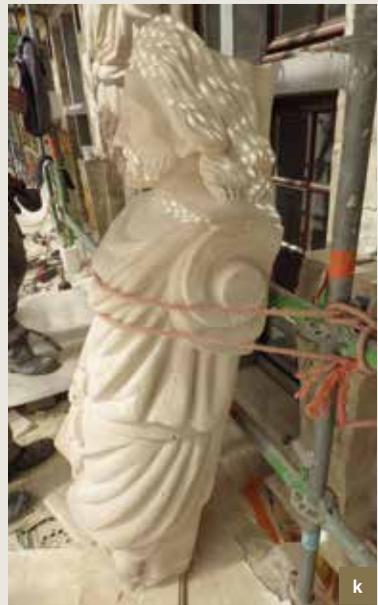
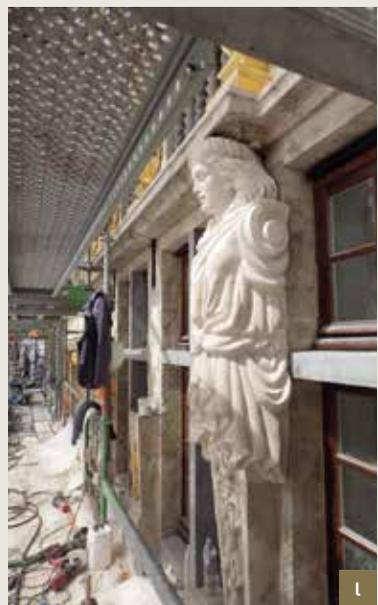
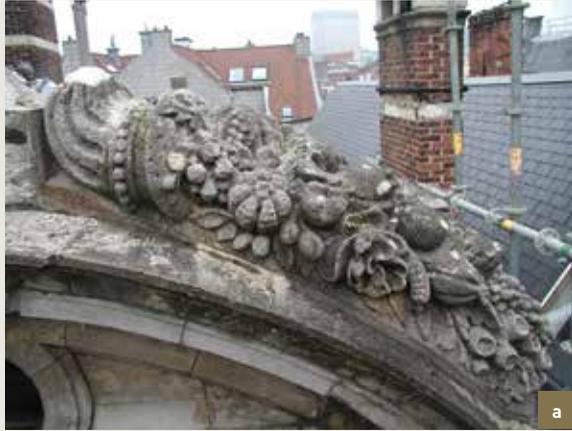
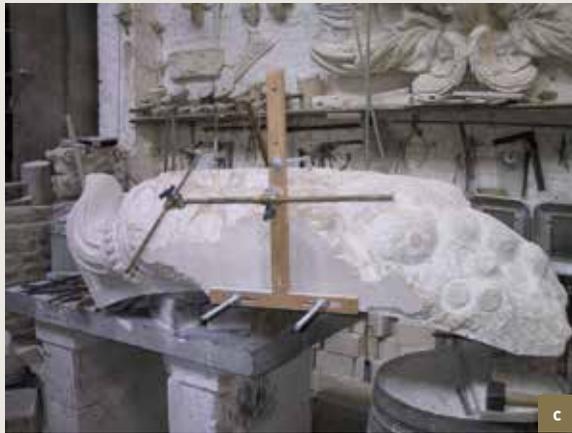
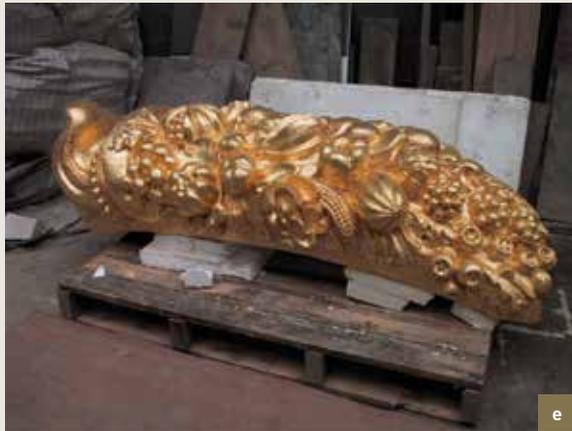
Le Sac/Den Sack. Stages in creating reproductions of the five statues based on the original models. a) The five covered statues (terms) before their replacement (© HHU, 2016); b) The five sculptures after replacement; c) and d) *In situ* repairs to statues that were too badly damaged (the metal elements had caused cracks and chips in the stone) with a view to making casts of the works; e) and f) Casting with silicone and fibreglass-reinforced polyester resin; g) Transportation of original elements (for documenting) after unmoulding; h) Manufacture of new sculptures (Savonnière stone) using the pointing method and based on the plaster model; i) and j) Work in progress with historical drawings and sculpting tools; k) and l) Mounting of new sculptures (© HHU, 2014-2015).

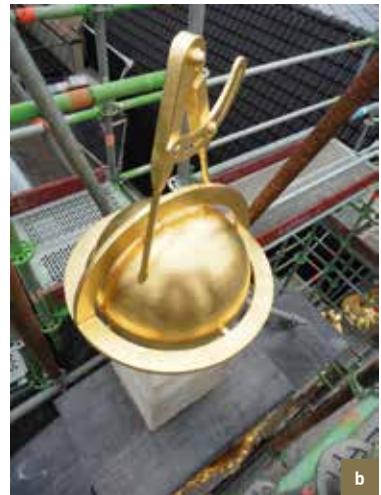
Le Sac/Den Sack. Globe. a) Archive drawing that was used for the creation of the new zinc globe, due to the existing globe being too badly damaged (© AVB); b) New gilded globe on the apex of the gable (© HHU, 2014-2015).

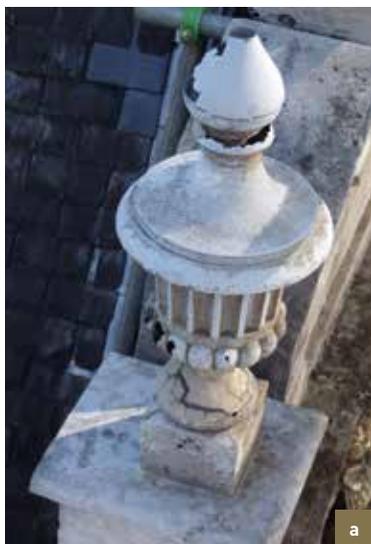
Le Sac/Den Sack. Zinc vase. a) Cracked and pockmarked original element; b) Old and new elements (© HHU, 2014-2015).

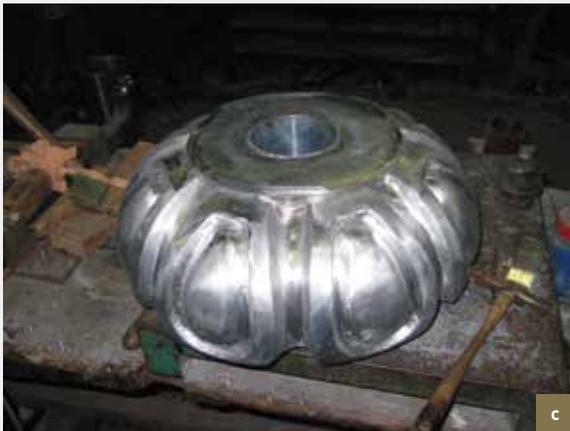
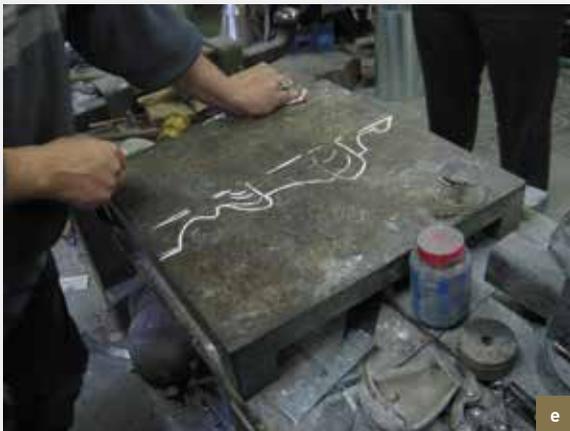
La Rose/De Roose. a) Partial view of the gable (© Utopix, M. Ploton, 2018); b) Detail of an original zinc vase; c), d) and e) Stages in the creation of a new vase in the workshop; f) The new gilded vases (© HHU, 2014-2015).

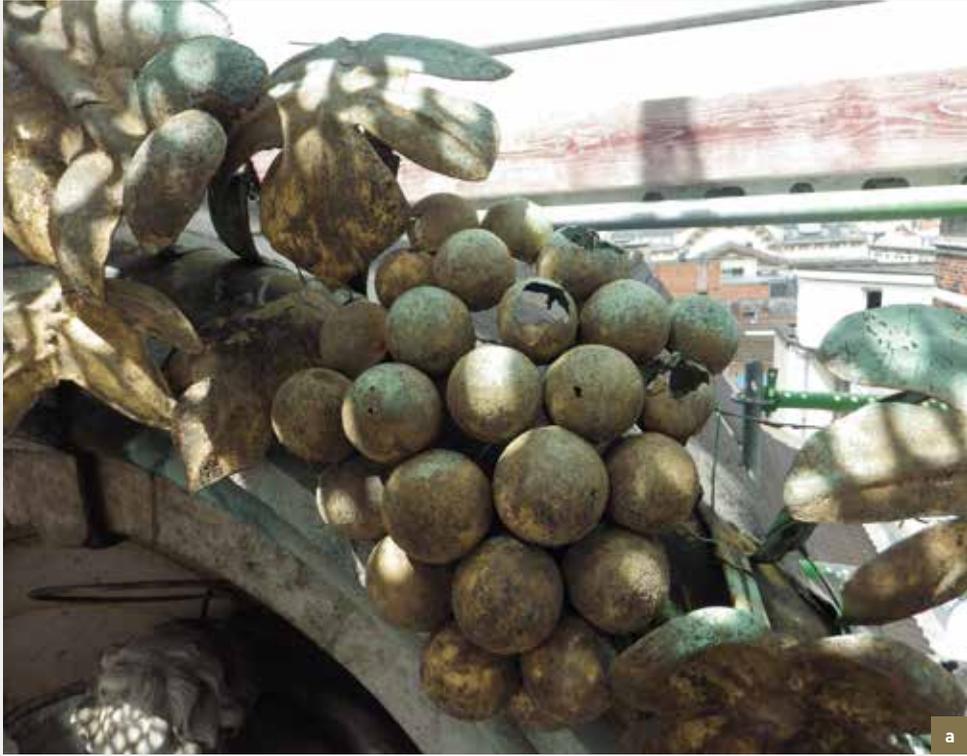
La Brouette/Den Cruywagen. Stages in the restoration of copper garlands. a) Condition before restoration (the bunches of grapes were badly corroded, some even having holes); b, c, d and e) Restoration in the workshop (with numbering), sanding with steel wool, cleaning with demineralised water and acetone, filling of holes (epoxy) and application of gilding (© HHU, 2014-2015).

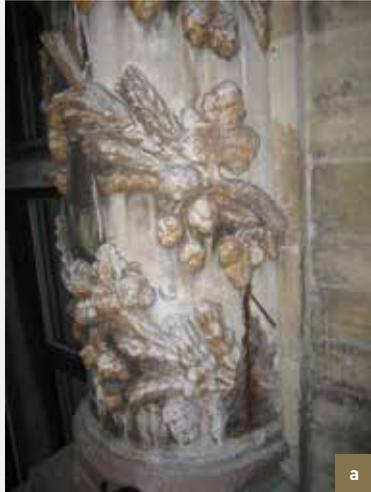
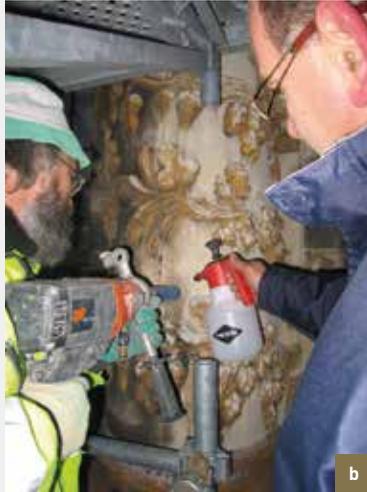
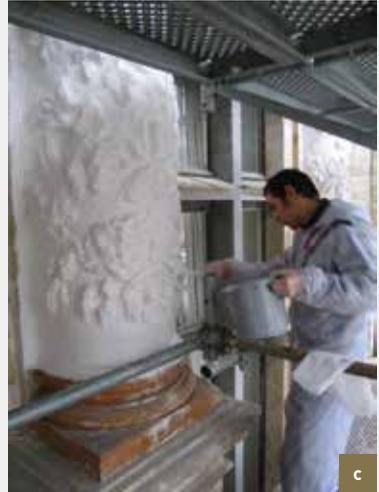
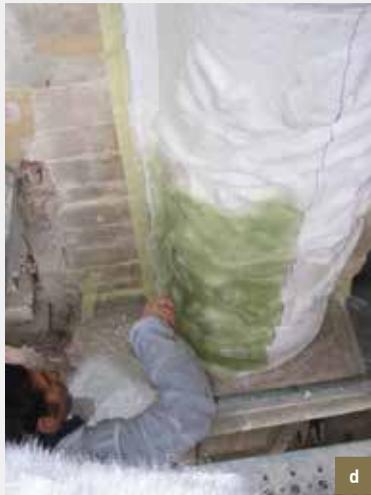
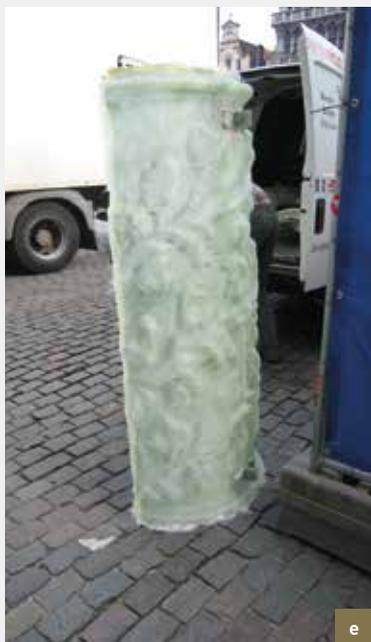
*La Maison des Brasseurs/Het Brouwerhuis. Column decorated with twisted foliage. a) The metal parts caused the element to crack or chip (cementing on original stone). Damaged state before casting and restoration; b) Core sampling of mortar; c) Moulding with silicone; d) Fibreglass-reinforced polyester resin shell; e) The cast is transported for possible reproduction; f) Finally, the elements were restored *in situ*, painted and gilded (© HHU, 2014-2015).*

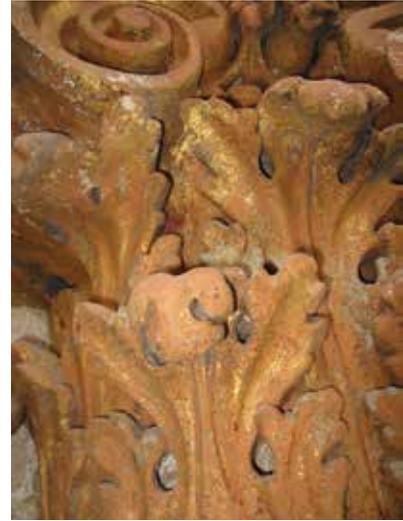
La Maison des Brasseurs/Het Brouwerhuis.
Detail of a composite capital, after cleaning and before restoration (© HHU, 2008).

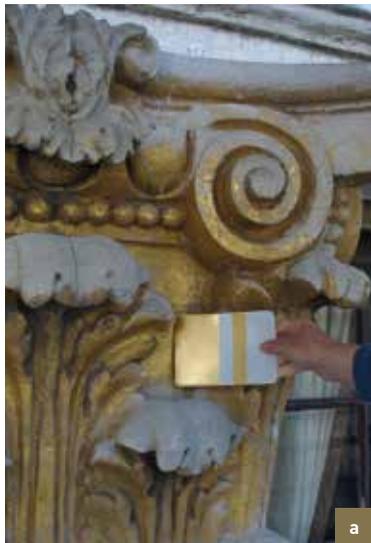
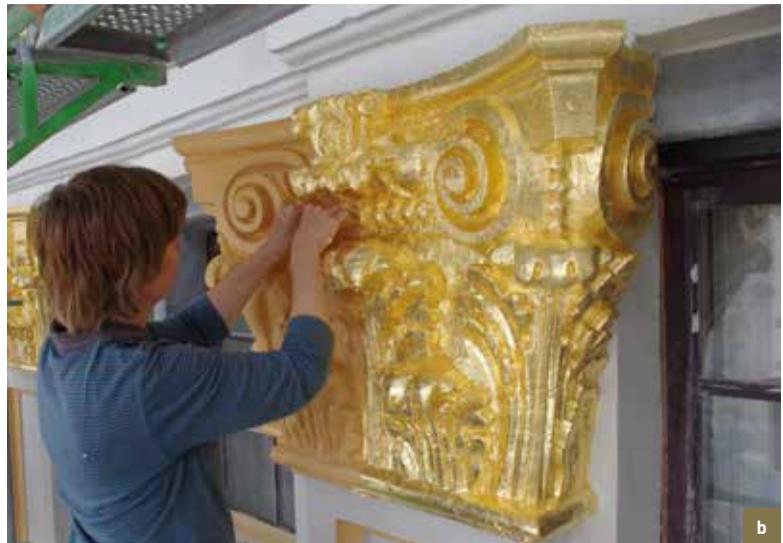
La Chaloupe d'Or/De Gulden Boot. Detail of a capital. a) Checking the gilding chosen; b) On the left: orange-yellow preparatory base layer. On the right: application of gold leaf on mixtion (© HHU, 2012).

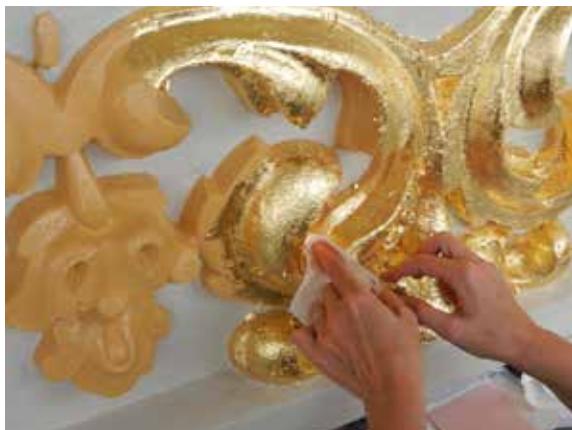
La Chaloupe d'Or/De Gulden Boot. Detail of frieze on the pediment during gilding (© HHU, 2012).

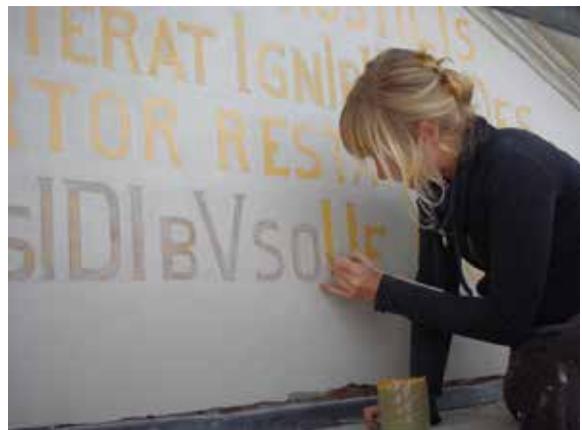
La Chaloupe d'Or/De Gulden Boot. Detail of the chronogram on the tympanum of the pediment. Lettering being painted, preparatory base layer for gilding (© HHU, 2012).

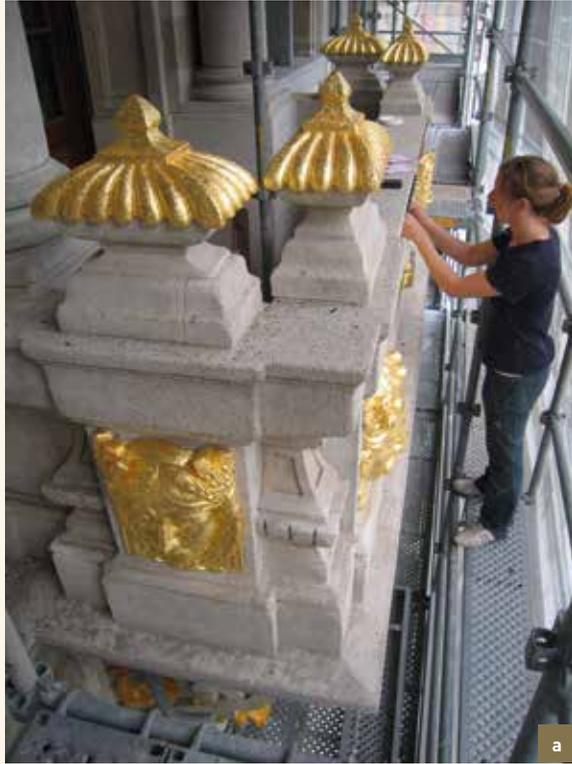
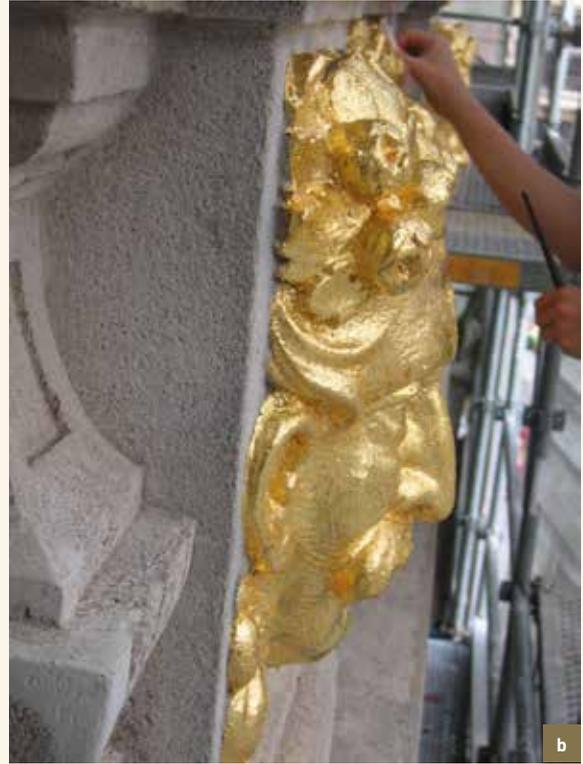
La Maison du Cygne/De Swane. a and b) The mascarons on the balcony during gilding (Venneman, 1903). Euville (© HHU, 2008).

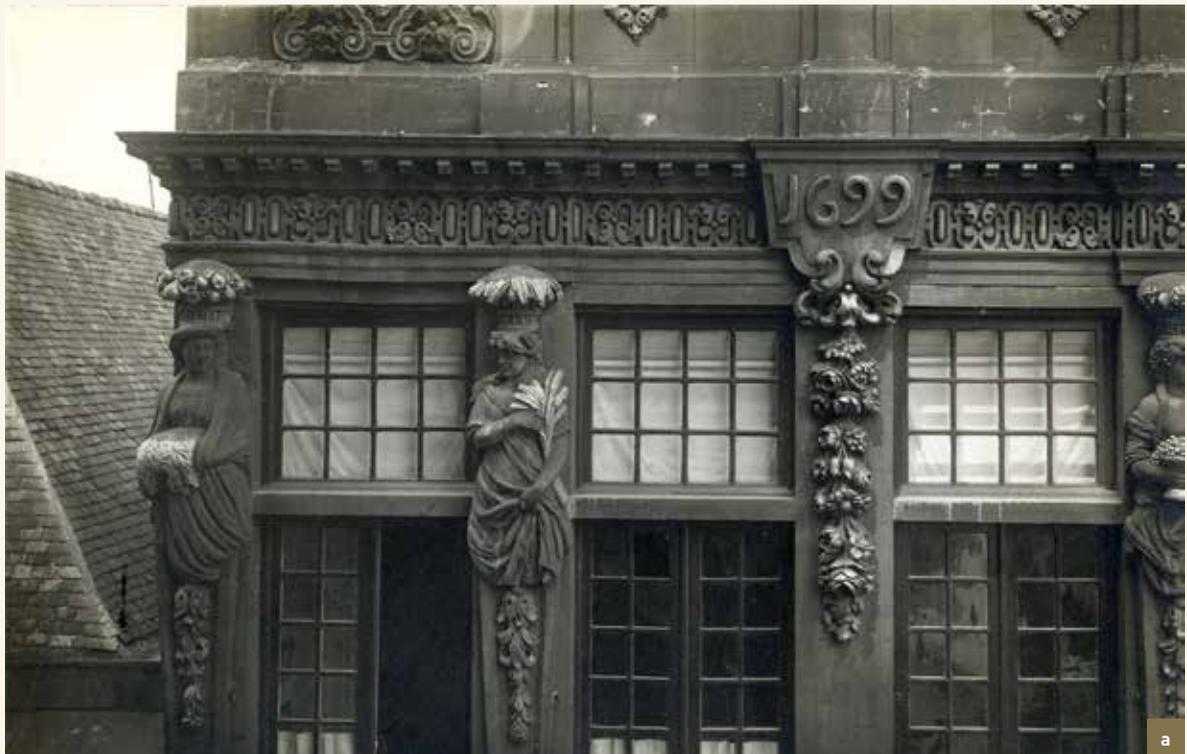
Le Renard/De Vos. Two female terms, holding a golden fleece and a sheaf of wheat, one crowned with a basket of fruit, the other with a sheaf of wheat (Edouard Geirnaert, 1884). a) Old photograph (© AVB, undated); b) After restoration. Euville stone (© Utopix, M. Ploton, 2018).

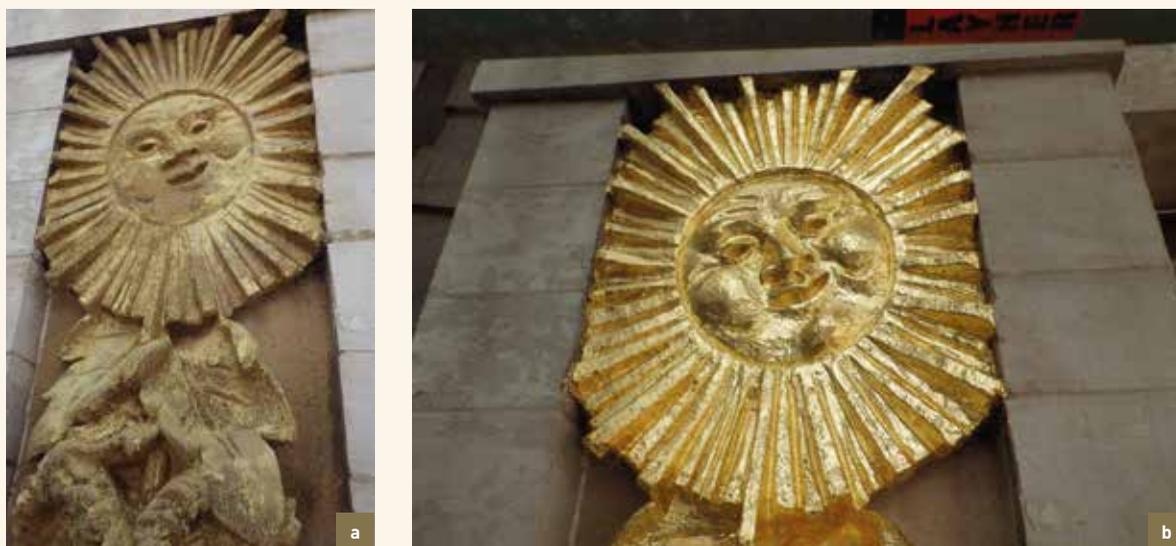
La Louve/De Wolvin. Detail of decoration on mullion with depiction of the sun. a) After cleaning; b) After application of gold leaf (© HHU, 2014-2015).

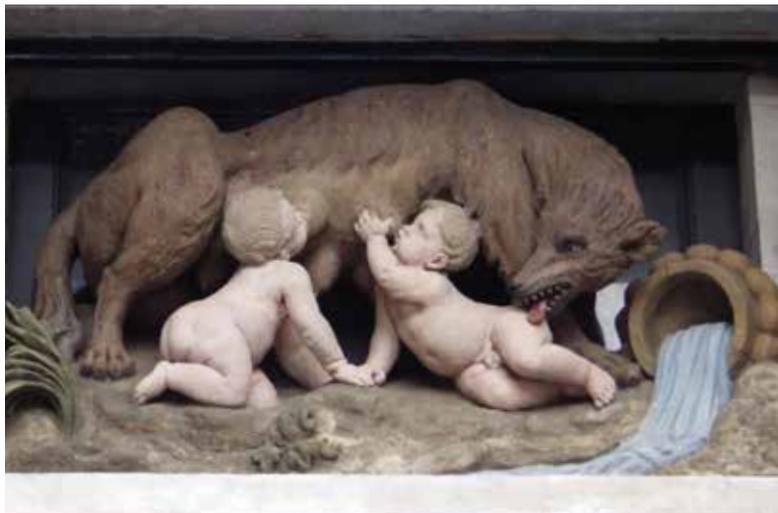
Restoration of the polychromy of the *La Louve/De Wolvin* sign (© HHU, 2015).

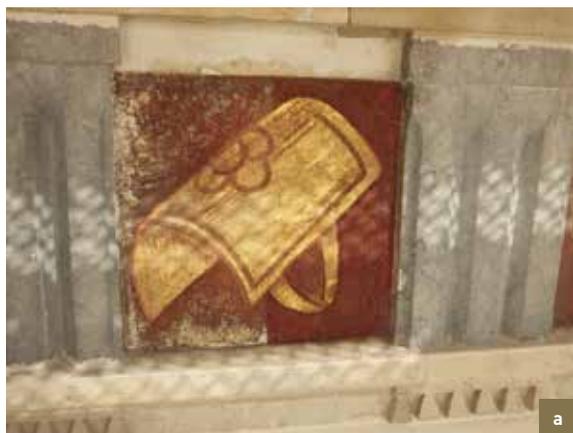
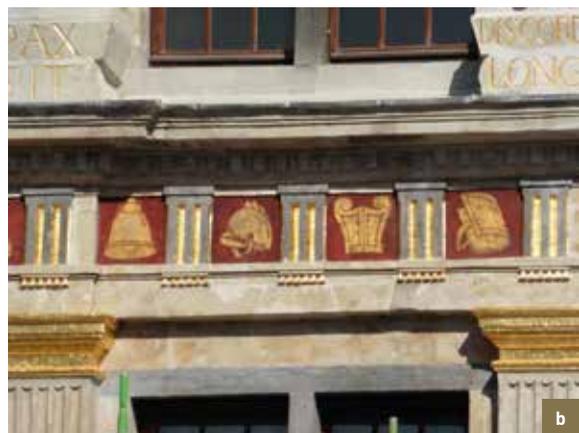
La Louve/De Wolvin. Detail of gold motif metopes in the frieze alluding to archers. a) Test restoration on the right-hand section; b) Final result (© HHU, 2014-2015).

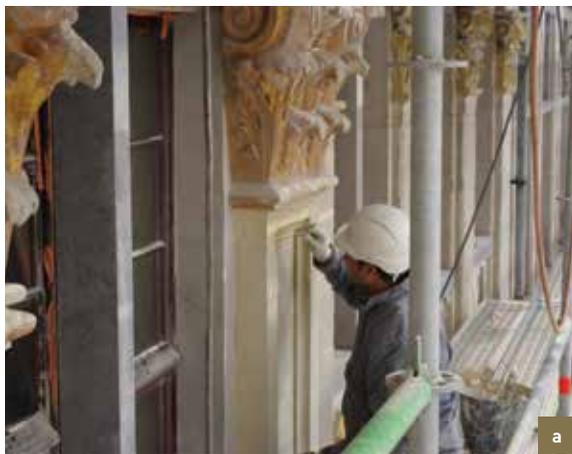
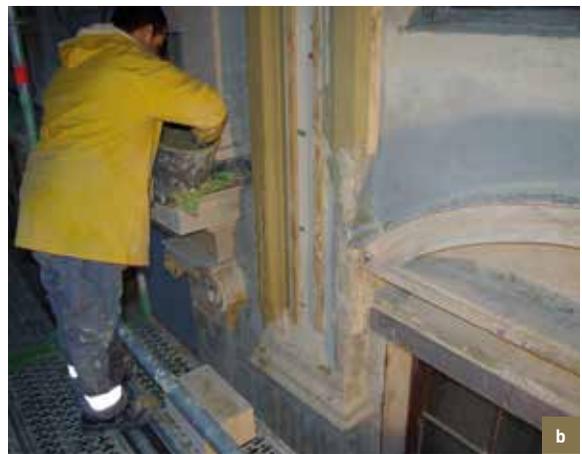
La Chaloupe d'Or/De Gulden Boot. a and b) Coating of colossal pilaster (© HHU, 2012).

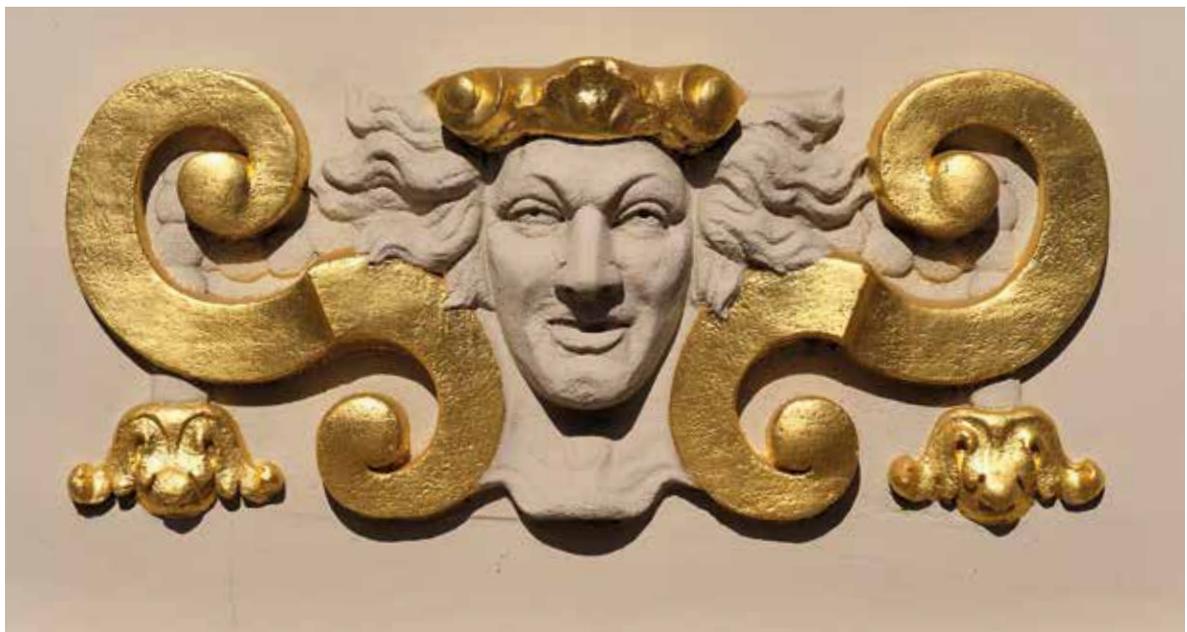
La Chaloupe d'Or/De Gulden Boot. Detail of a painted and gilded mascarón (© Utopix, M. Ploton, 2018).
